Cape Town, Oude Molen Precinct

TREES AND SHRUBS QUALITY SURVEY

Planning Partners
Landscape Architects

Western Cape Government

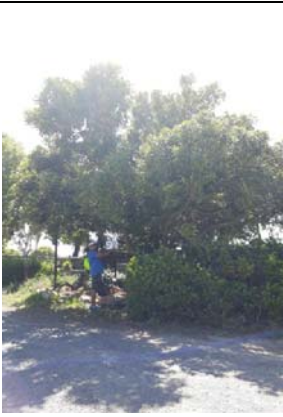
<i>Ficus natalensis</i>	MS (1)	13.5	9-10	Fair condition, requires pruning
79.

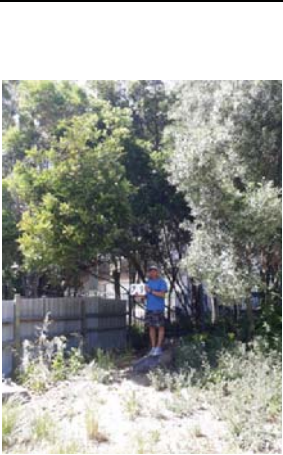
<i>Ceratonia siliqua</i>	0.25	5	5.5	Fair condition, dead wood, needs pruning
80.

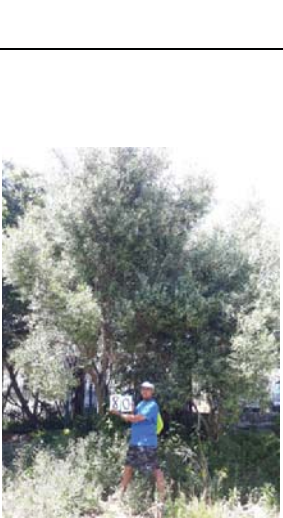
<i>Olea sp.</i>	0.3	4.5	5	Windblown, leaning, fair condition, Requires pruning

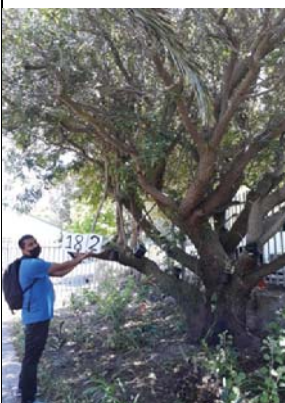
<i>Schinus terebinthifolia</i>	1.1	12	9	Dead wood, damaged by pruning, fair condition, invader
183.

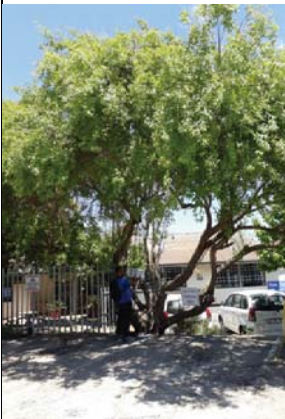
<i>Searsia pendulina</i>	1.1	14	7	Damaged by pruning

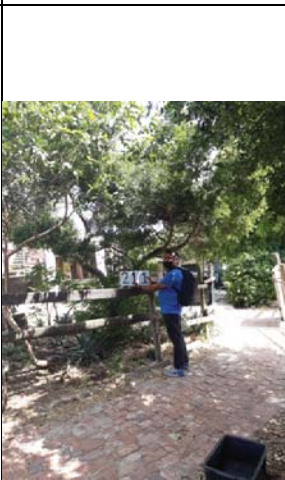
<i>Afrocarpus falcatus</i>	0.12	5	6	Untidy growth, damaged by pruning

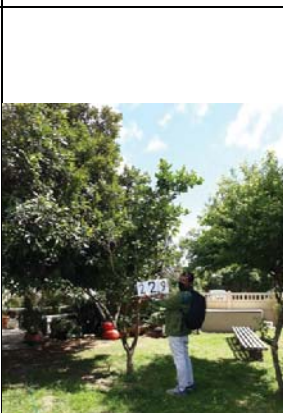
<i>Lemon eureka</i>	0.1	2.5	4.5	Dead wood, poor condition

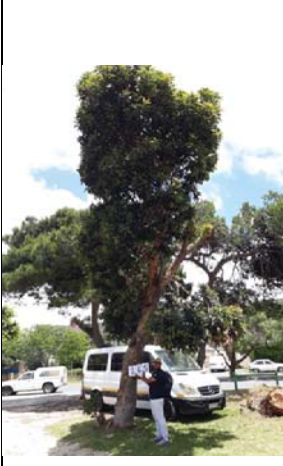
<i>Eucalyptus ficifolia</i>	0.6	5	9	Bad condition, dead wood, poor condition

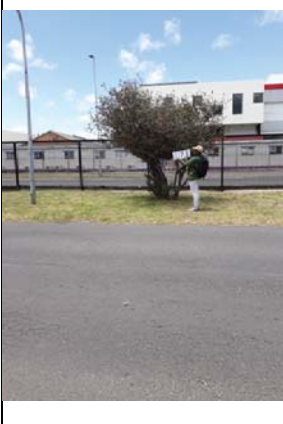
<i>Callistemon sp.</i>	MS (1)	6	3	Old, damaged, windblown, poor condition
279.

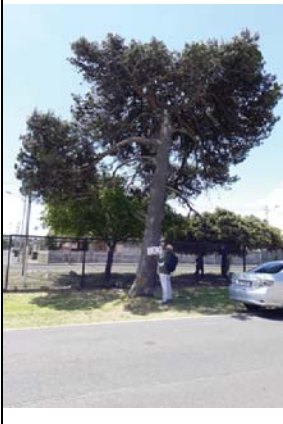
<i>Pine sp.</i>	0.66	14	10-12	Mature, dead wood, poor condition
288.
