## SETTLEMENT PROFILE

# Tambo Transit Camp

Municipality: **BITOU MUNICIPALITY**

B1 - IN-SITU UPGRADING

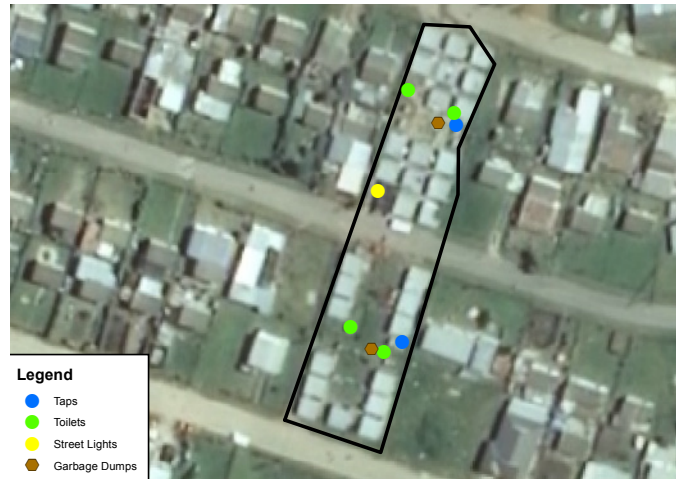
## SETTLEMENT MAP

The settlement has an adequate waste management system. The municipality should give black bags to the community and provide each household with an individual bin for waste removal. There is an adequate level of water and sanitation provision in the settlement. The municipality fixes broken taps, but does not fix leaking taps. The settlement needs a maintenance plan which could involve the uptake of EPWP workers. The existing electrical connections are unstable and require maintenance so that electricity does not shut off during strong winds. The settlement's street lights do not work. The settlement requires a sustainable maintenance plan as well as a reporting protocol so that the municipality can be informed when services are not operational. The settlement has tarred roads and channels, but still relies on channels dug out by the community for storm water drainage.

- Provide black bags and individual bins.
- Provide 1 legal prepaid electrical connection.
- Fix 3 street lights so that the streets are electrified, allowing the community to safely access water and sanitation services at night.
- The municipality, together with the community, should develop a reporting protocol and maintenance plan for the upkeep of existing infrastructure.
- Apply concrete to community dug out channels.

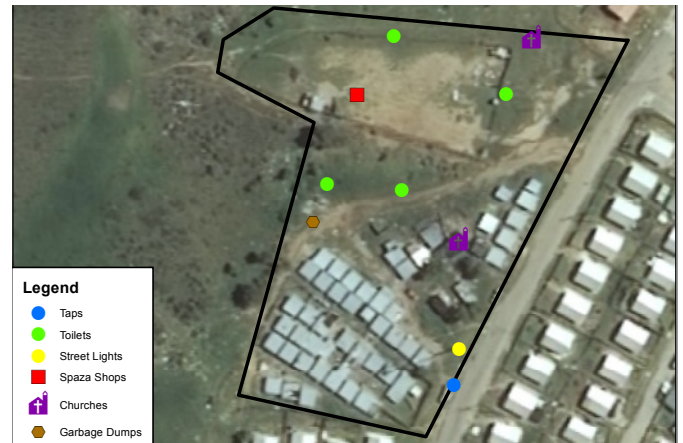
## SETTLEMENT MAP

The settlement experiences a range of locational hazards and risks which are further compounded by man-made hazards. Through formalising a of the portion of the settlement these can be mitigated. Reblocking the settlement will establish clear access and egress routes as well as pedestrian and vehicular routes. Moreover, concrete drainage channels will mitigate water logging and flooding. Through the implementation of short term priorities waste management and access to adequate basic services will be improved.

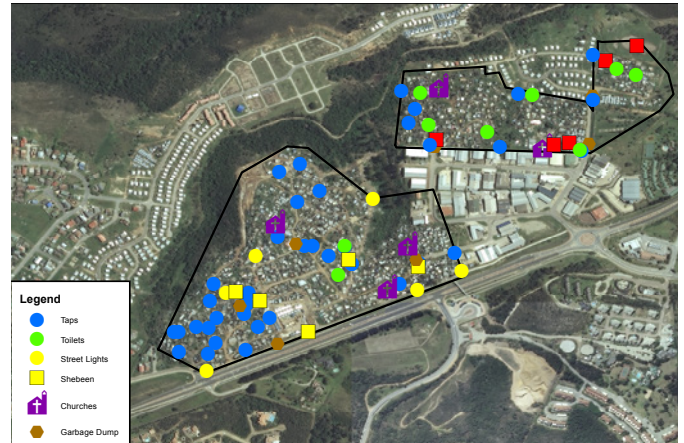
## SETTLEMENT MAP

The settlement experiences a range of locational hazards and risks such as its location in a flood-prone area, close to a garbage dump, next to a road, on a slope and under power lines. These locational hazards are further compounded by the fact that the settlement has a high population density, poor street network and suffers from water logging. Incrementally formalising the settlement will immediately provide an improved street network and eliminate the issue of water logging. This will entail installing concrete drainage channels and reblocking in the initial phases. The municipality needs to support a community-driven development process. Furthermore, the construction of a settlement boundary wall will mitigate the negative social impacts of the settlement’s roadside location.

- Facilitate a working meeting with the community and communicate future plans in order to address community priorities.
- Provide black bags more regularly and provide more skips.
- Repair 27 communal standpipes.
- Repair 36 toilets and provide 26 toilets to meet national standards.

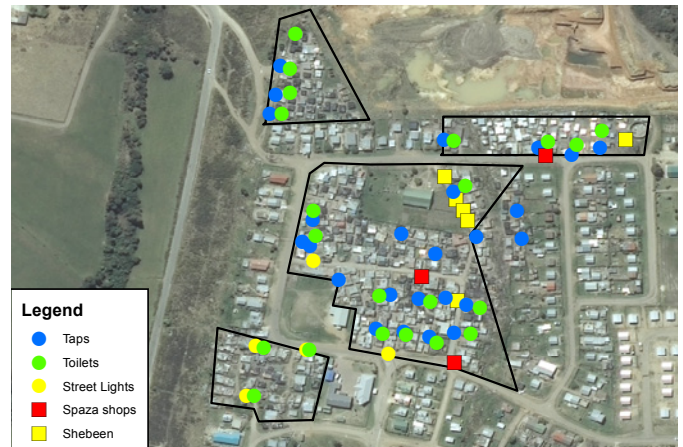
## SETTLEMENT MAP

The settlement has a poor level of basic service delivery with a large sanitation shortfall (40 toilets). Infrastructure maintenance is an issue as repairs take longer than 2 months to be completed. 17 toilets and 2 communal standpipes require repair. The community has a good level of access to electricity, but the municipality should replace the few existing illegal connections with legal ones. Waste is regularly collected from individual bins but for a settlement of this density and size, it would be prudent to provide a municipal skip for residents to dump waste when individual bins fill up.

- Facilitate a working relationship with the community.
- Social facilitation is needed to help set up a leadership structure.
- Install concrete storm water channels.
- Provide 23 toilets and repair 17 toilets.
- Repair 2 communal standpipes.
- Investigate providing a municipal skip.
- Provide legal electrical connections for those using illegal ones.

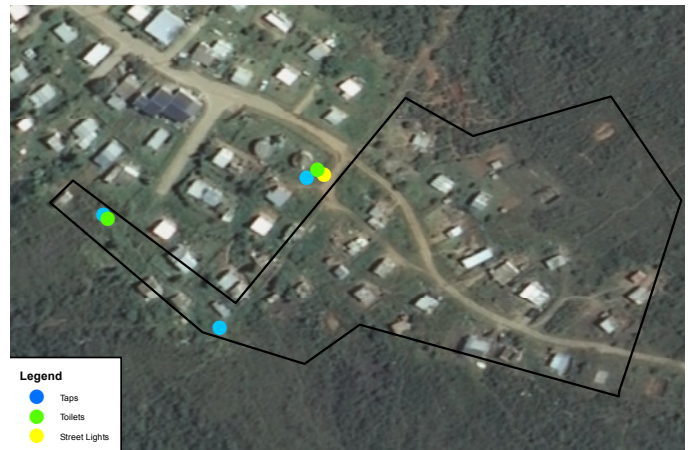
## SETTLEMENT MAP

The municipality must repair 1 flush toilet to meet the sanitation shortfall. Maintenance issues usually take more than 2 months to be addressed. The municipality should make use of the EPWP programme to employ community members in maintaining infrastructure. 19 pre-paid electrical connections should be installed to ensure access to electricity for all households in the community.

- Stabilise the road with gravel to facilitate vehicle access.
- Increase the number of street lights.
- Install concrete storm water channels.
- Repair 1 toilet.
- Social facilitation is needed to establish a community leadership structure.
- The municipality should work on its relationship with the community.

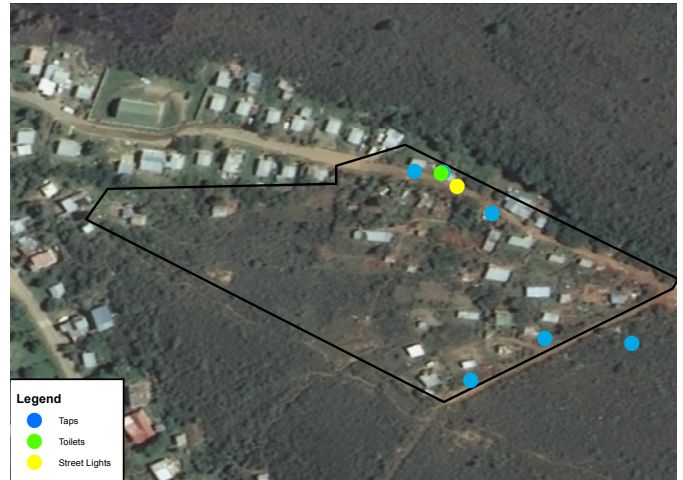
## SETTLEMENT MAP

Basic service delivery to the community is average. Water provision exists, but is located far away and 2 standpipes need to be repaired. There is a shortfall of 5 toilets with 2 requiring repair. Only 15 of 50 households have access to electricity. Waste is collected regularly from municipal skips, but black bags are handed out irregularly to the community. Maintenance issues are reported to the community liaison officer and it takes about 1 month to repair infrastructure. The municipality must address the shortfall of sanitation services and needs to ensure that maintenance work is carried out effectively. The municipality should also consider the possibility of moving water infrastructure closer to the community and should provide electrical connections to 35 households.

- Repair the access road to the settlement.
- Provide 3 flush toilets and repair 2 flush toilets.
- Repair 2 communal standpipes.
- Install concrete storm water channels.
- Regularly distribute black bags.
- Establish a working relationship with the community.
- Social facilitation is needed to set up a ward committee.
