Cape Town, Oude Molen Precinct

TREES AND SHRUBS QUALITY SURVEY

Planning Partners
Landscape Architects

Western Cape Government

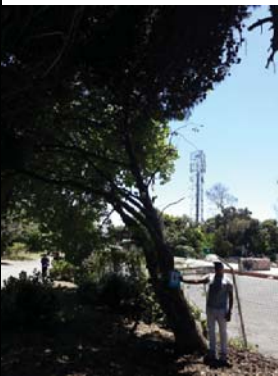
NO	TREE PHOTOGRAPHIC RECORD	SPECIES	GIRTH (m)	CANOPY (m)	HEIGHT (m)	COMMENT
4.

<i>Platanus x acerfolia</i>	0.8	13	10+	Split stem, heavy leaning, wind blown
5.

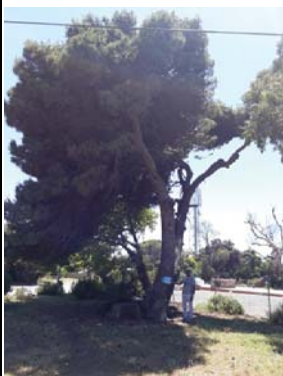
<i>Pinus sp.</i>	1.2	11	11	Split stem, mature, very old
6.

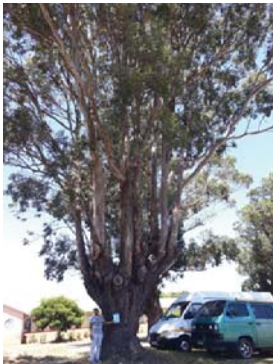
<i>Eucalyptus sp.</i>	1.8	18	20	Mature, very old

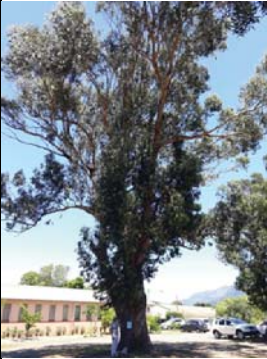
NO	TREE PHOTOGRAPHIC RECORD	SPECIES	GIRTH (m)	CANOPY (m)	HEIGHT (m)	COMMENT
7.

<i>Eucalyptus sp.</i>	1.8	19	20	Mature, very old
8.

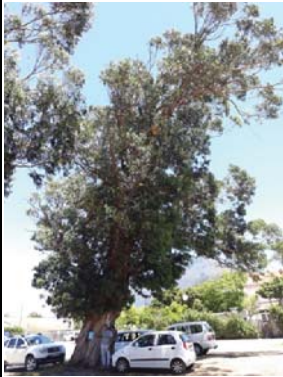
<i>Eucalyptus sp.</i>	1.8	19	18	Leaning
9.

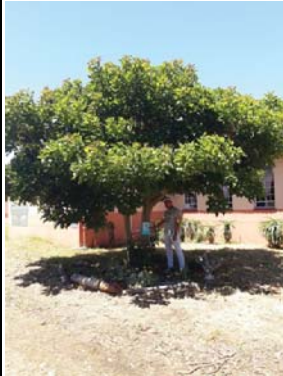
<i>Erythrina sp.</i>	0.4	9	6	Split stem, Good condition, healthy

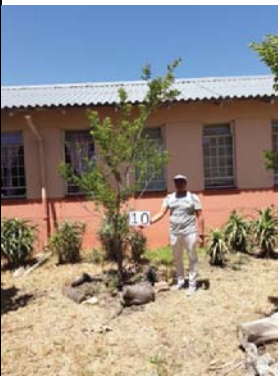
NO	TREE PHOTOGRAPHIC RECORD	SPECIES	GIRTH (m)	CANOPY (m)	HEIGHT (m)	COMMENT
10.

<i>Celtis sp.</i>	0.1	1.7	2.5	Newly planted, young, healthy
11.

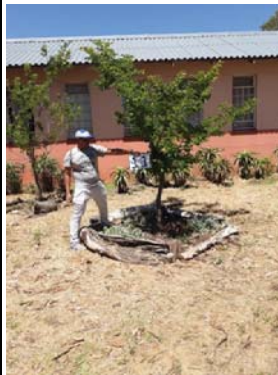
<i>Celtis sp.</i>	0.1	1.7	2.5	Newly planted, young, healthy
12.

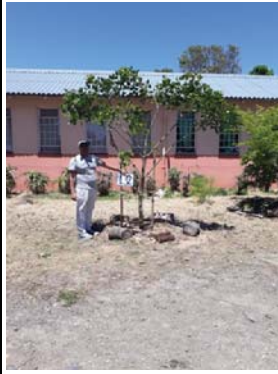
<i>Erythrina sp.</i>	0.15	3	2.5	Newly planted, young, healthy

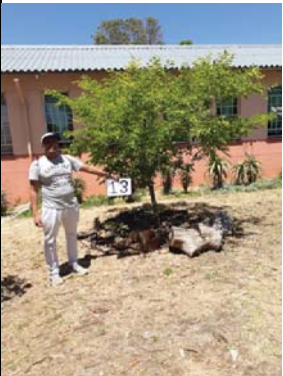
NO	TREE PHOTOGRAPHIC RECORD	SPECIES	GIRTH (m)	CANOPY (m)	HEIGHT (m)	COMMENT
13.

<i>Celtis sp.</i>	0.1	3	2.5	Young, newly planted
14.

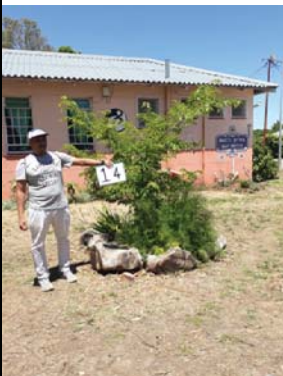
<i>Celtis sp.</i>	0.1	2	2	Young, newly planted
15.

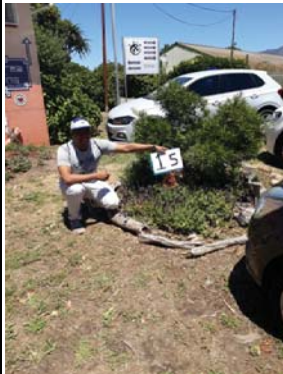
<i>Afrocarpus falcatus</i>	0.1	1	1	Shrub size

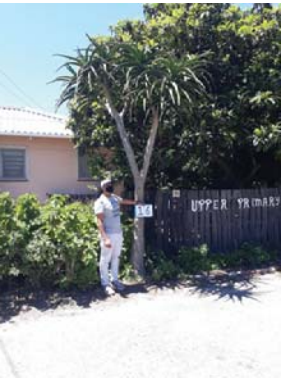
NO	TREE PHOTOGRAPHIC RECORD	SPECIES	GIRTH (m)	CANOPY (m)	HEIGHT (m)	COMMENT
16.

<i>Aloidendron barberae</i>	0.3	2.5	4.5	Focal element
17.

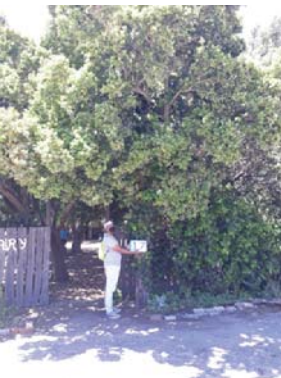
<i>Syzygium cordatum</i>	0.35	6	7	Diseased, old
18.

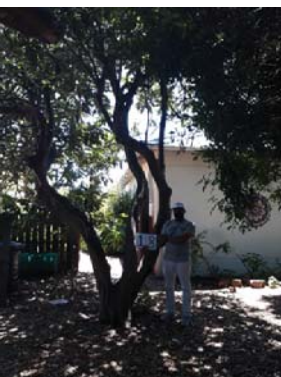
<i>Eriobotrya japonica</i>	7	6	0.7	Split stem, invader, Mature, Dead wood

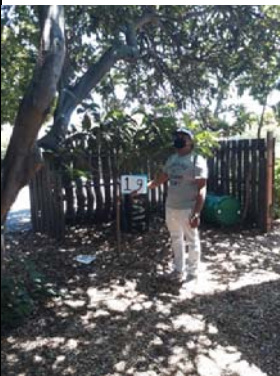
NO	TREE PHOTOGRAPHIC RECORD	SPECIES	GIRTH (m)	CANOPY (m)	HEIGHT (m)	COMMENT
19.

<i>Eriobotrya japonica</i>	0.1	2.5	2	Healthy, young.
20.

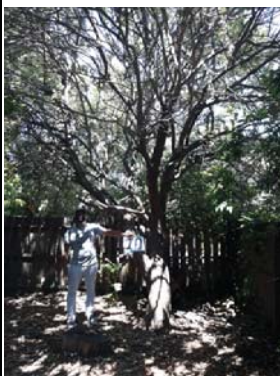
<i>Tarchonanthus camphoratus</i>	0.35	12	7	Mature, healthy, dead wood.
21.

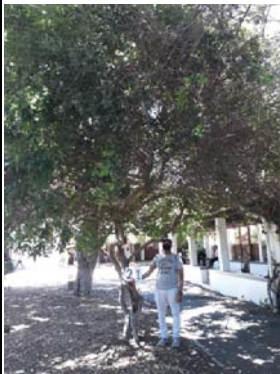
<i>Salix capensis</i>	0.2	5	5	Twining stem, fair condition

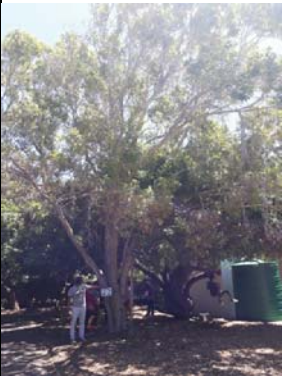
NO	TREE PHOTOGRAPHIC RECORD	SPECIES	GIRTH (m)	CANOPY (m)	HEIGHT (m)	COMMENT
22.

<i>Syzygium guineense</i>	0.8	11	9	Mature, old, multi stem
23.

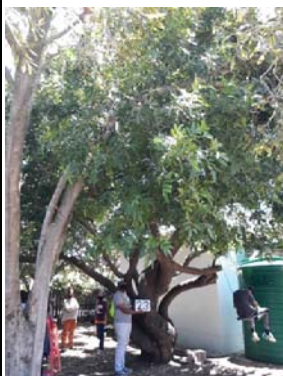
<i>Schinus terebinthifolius</i>	0.9	14	6	Multi stem, mature.
24.

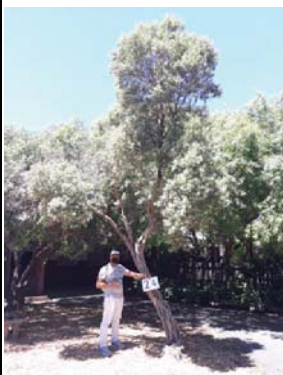
<i>Olea europea subsp. Africana</i>	0.35	4	8	mature, very old, dead wood

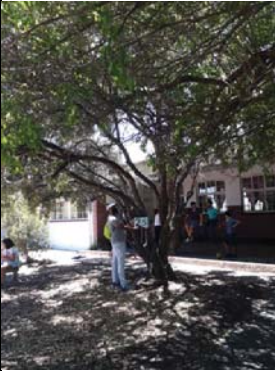
NO	TREE PHOTOGRAPHIC RECORD	SPECIES	GIRTH (m)	CANOPY (m)	HEIGHT (m)	COMMENT
25.

<i>Olea sp.</i>	0.8	10	7	Spreading, requires pruning
26.

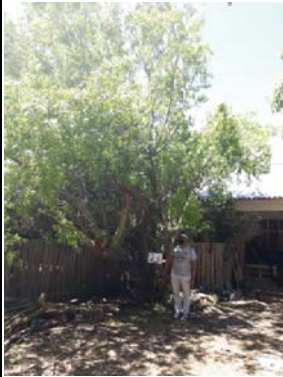
<i>Searsia pendulina</i>	1	17	7-8	Spreading canopy
27.

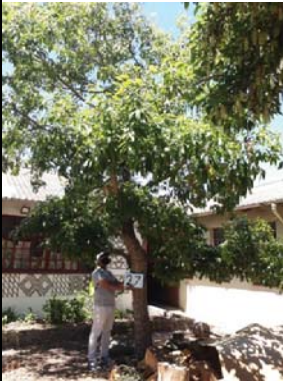
<i>Quercus suber</i>	0.3	9	8	Good condition, healthy

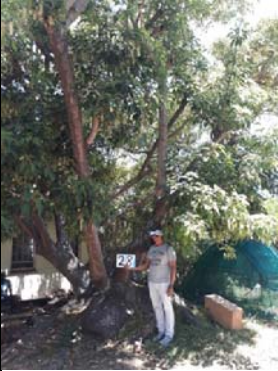
NO	TREE PHOTOGRAPHIC RECORD	SPECIES	GIRTH (m)	CANOPY (m)	HEIGHT (m)	COMMENT
28.

<i>Phytolacca dioica</i>	4	12	8-9	Invasive, Good condition
29.

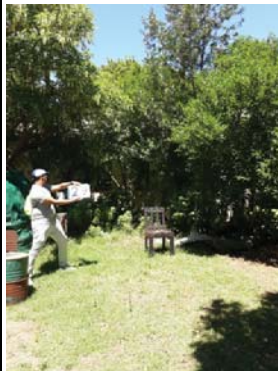
-Unknown shrub - <i>Virgilia oroboides</i>	MS	5	4	cluster, healthy
30.

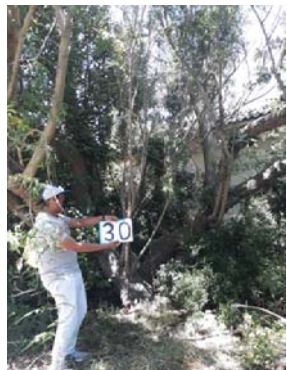
<i>Tarchonanthus camphoratus</i> - <i>Syzygium guineense</i> - <i>Searsia pendulina</i> - <i>Celtis sp.</i>

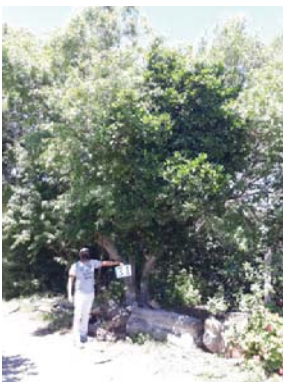
NO	TREE PHOTOGRAPHIC RECORD	SPECIES	GIRTH (m)	CANOPY (m)	HEIGHT (m)	COMMENT
31.

<i>Sideroxylon inerme</i>	0.8	5	5	Split stem, broken, damaged, Poor cond.
32.

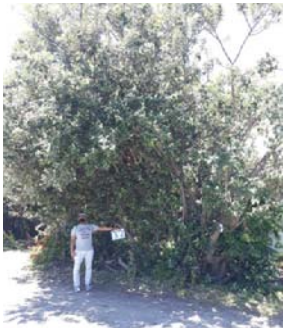
<i>Tarchonanthus camphoratus</i>	MS	8	5	Hedge, Spreading, damaged.

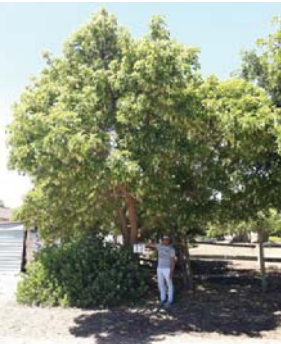
NO	TREE PHOTOGRAPHIC RECORD	SPECIES	GIRTH (m)	CANOPY (m)	HEIGHT (m)	COMMENT
33.

<i>Phytolacca dioica</i>	1.2	9	9	Exposed roots, Good condition, Invader
34.

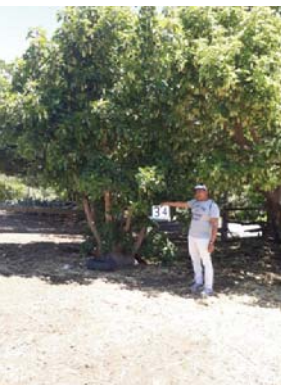
<i>Phytolacca dioica</i>	1	4	6	Exposed roots, Multi stem, split stem
35.

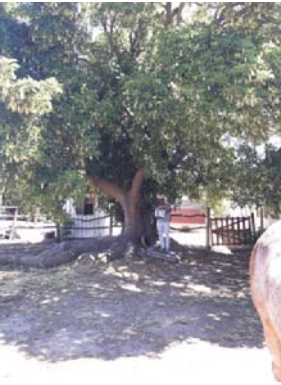
<i>Phytolacca dioica</i>	7	15	10	Exposed roots, Mature, healthy, invader.

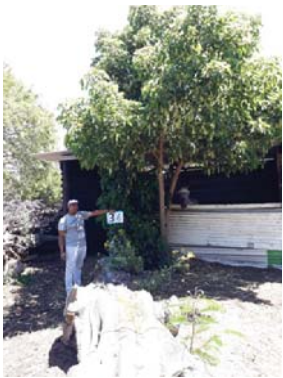
NO	TREE PHOTOGRAPHIC RECORD	SPECIES	GIRTH (m)	CANOPY (m)	HEIGHT (m)	COMMENT
36.

<i>Phytolacca dioica</i>	MS(3)	6	5	Exposed roots, Invader
37.

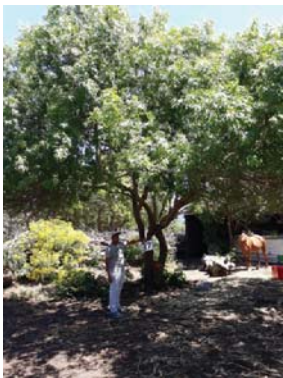
<i>Searsia pendulina</i>	MS (0.8)	11	5	Raised roots, Fair condition, Spreading
38.

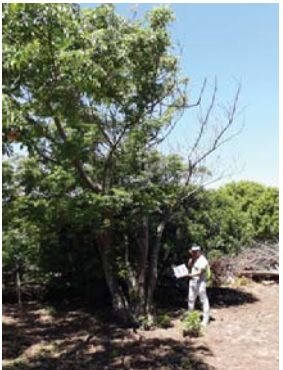
<i>Melia azedarach</i>	1.2	10	8	Poor condition, Windblown, dead wood.

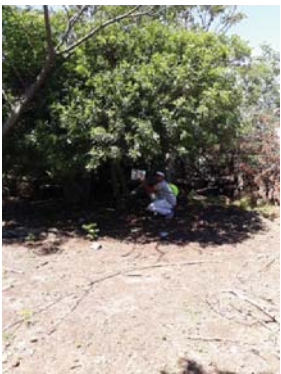
NO	TREE PHOTOGRAPHIC RECORD	SPECIES	GIRTH (m)	CANOPY (m)	HEIGHT (m)	COMMENT
39.

<i>Schinus terebinthifolius</i>		8	4	cluster
40.

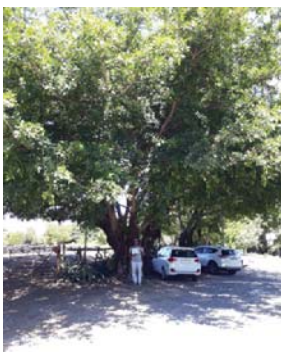
<i>Ficus sp.</i>	1.7	19	10	Spreading, very healthy
41.

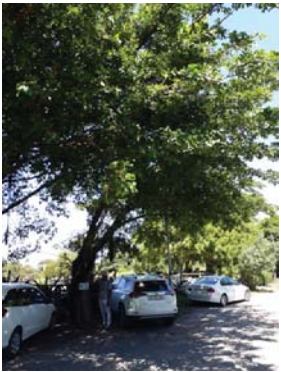
<i>Ficus sp.</i>	11	13	9	Leaning over

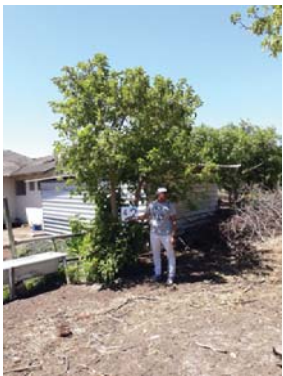
NO	TREE PHOTOGRAPHIC RECORD	SPECIES	GIRTH (m)	CANOPY (m)	HEIGHT (m)	COMMENT
42.

<i>Phytolacca dioica</i>	MS (1)	2.5	3.5	Exposed roots, Damaged, invader
43.

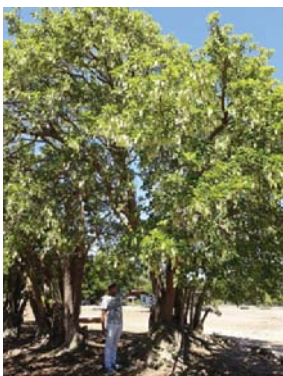
<i>Phytolacca dioica</i>	2	7	7	Exposed roots, Damaged, invader
44.

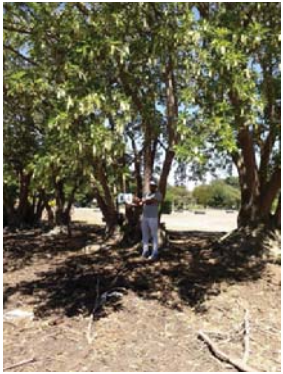
<i>Phytolacca dioica</i>	2	7	6	Exposed roots, Damaged, invader

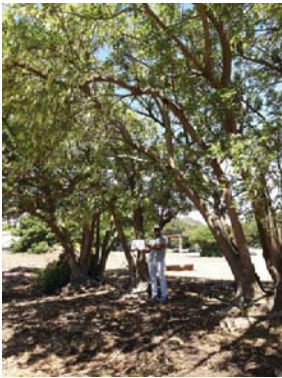
<i>Phytolacca dioica</i>	1.5	7	5	Exposed roots, Damaged, invader
46.

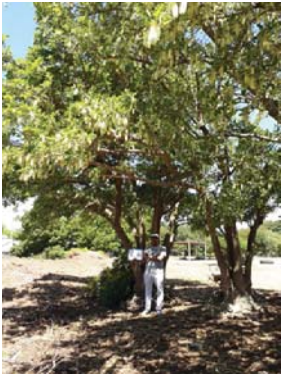
<i>Phytolacca dioica</i>	1.6	7	6	Exposed roots, Damaged, invader
47.

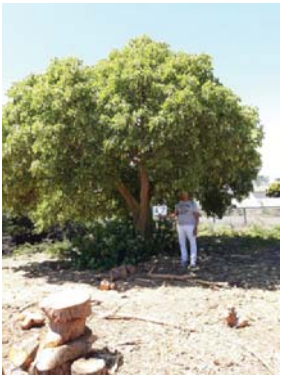
<i>Phytolacca dioica</i>	2.5	11	5	Exposed roots, Fair condition

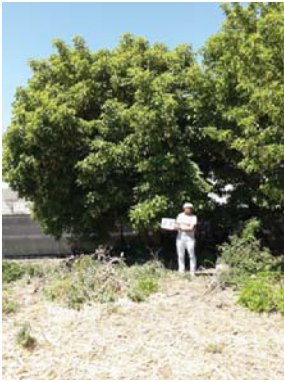
<i>Phytolacca dioica</i>	2	8	5	Exposed roots
49.

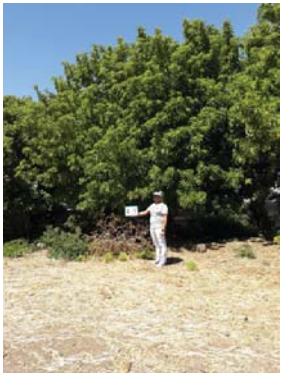
<i>Phytolacca dioica</i>	3	8	5	Exposed roots, Good condition
50.

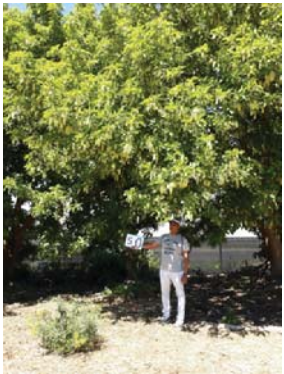
<i>Phytolacca dioica</i>	1.5	8	5	Exposed roots, Fair condition

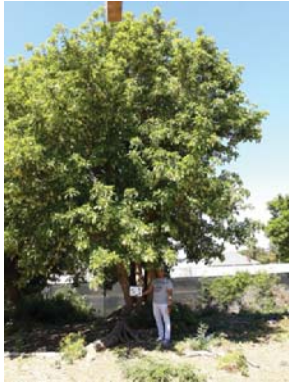
<i>Phytolacca dioica</i>	4	8	5	Exposed roots, Exposed root
52.

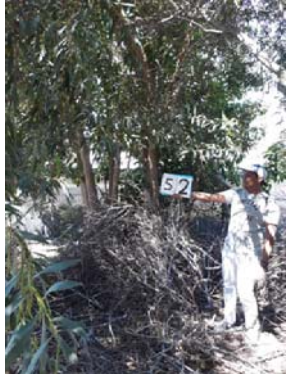
<i>Phytolacca dioica</i>	MS (2)	8	5	Exposed roots, Damaged
53.

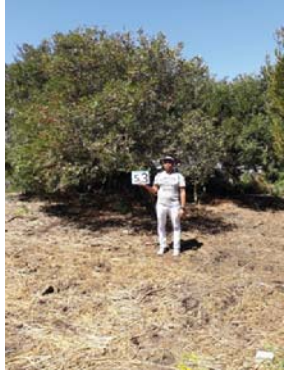
<i>Melaleuca quinque x 7</i>	MS (0.3)		4.5	Cluster, diseased

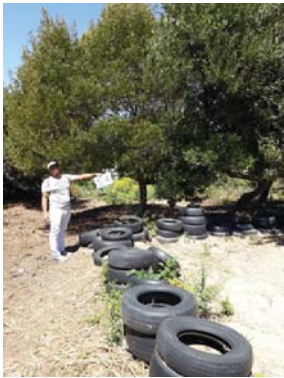
<i>Melaleuca quinque x 4</i>	MS (0.3)		5	Cluster, diseased
55.

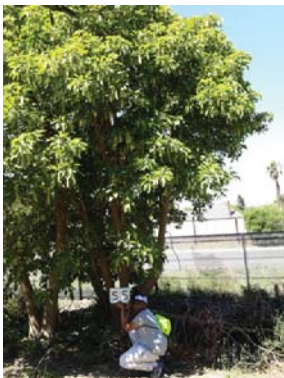
<i>Phytolacca dioica</i>	MS (1.8)	4	7	Exposed roots, fair condition
56.

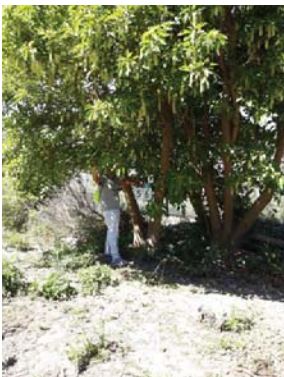
<i>Phytolacca dioica</i>	MS (1)	4	7	Exposed roots, fair condition

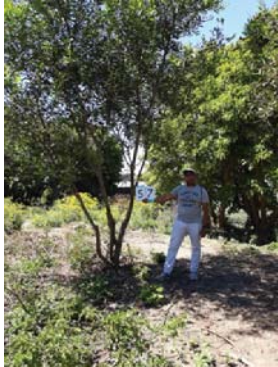
<i>Melaleuca quinque</i>	MS (0.1)	4	7	Cluster, diseased
58.

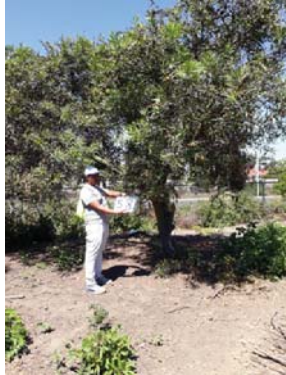
<i>Melaleuca quinque</i>	MS (0.1)	4	7	Cluster, diseased
59.

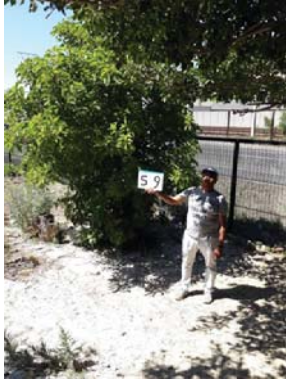
<i>Phytolacca dioica</i>	0.8	3	4.5	Exposed roots, Poor condition, invader

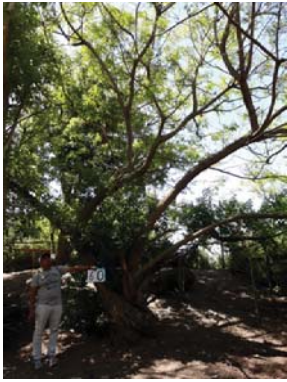
<i>Robinia pseudoacacia</i>	1.1	14	9-10	invader, Poor condition, Damaged
61.

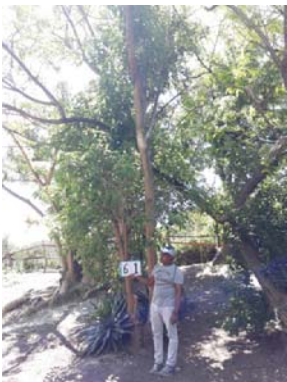
<i>Phytolacca dioica</i>	0.8	3	8	Exposed roots, Poor condition
62.

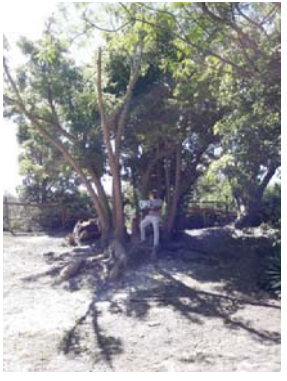
<i>Phytolacca dioica</i>	3.5	10	11	Exposed roots

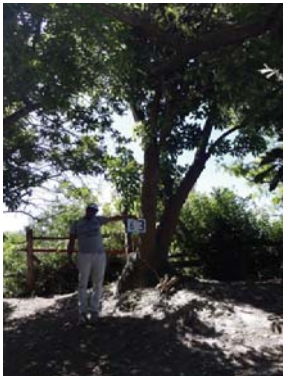
<i>Phytolacca dioica</i>	1.5	5.5	9-10	Exposed roots, Poor condition, Damaged
64.

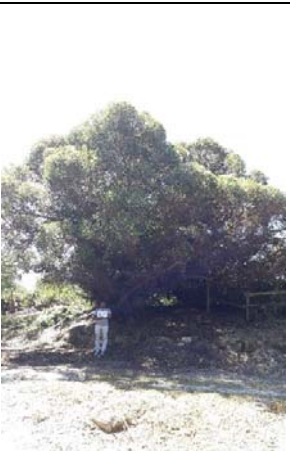
<i>Eucalyptus conferruminata</i>		17	10	Poor condition, old, spreading
65.

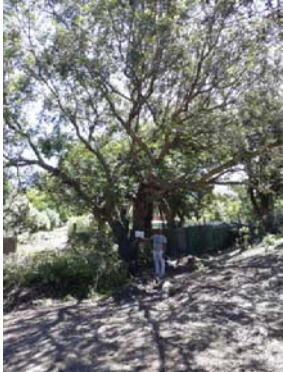
<i>Ekebergia sp.</i>	0.8	12	9-10	Old, mature, dead wood

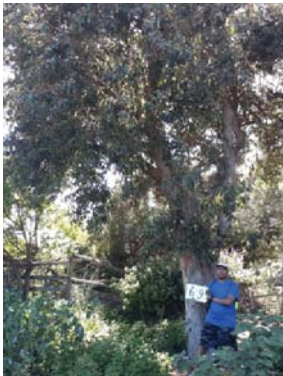
<i>Eucalyptus sp.</i>	0.8	5	11	Mature, Good condition, Dead wood
70.

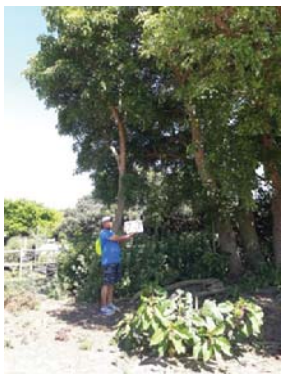
<i>Phytolacca dioica</i>	2.1	11	3	Exposed roots, spreading canopy, mature
73.

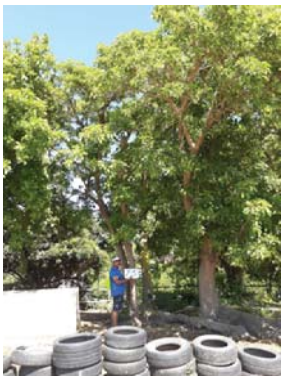
<i>Phytolacca dioica</i>	MS (1)	5	13	Exposed roots, Fair condition, dead wood
76.

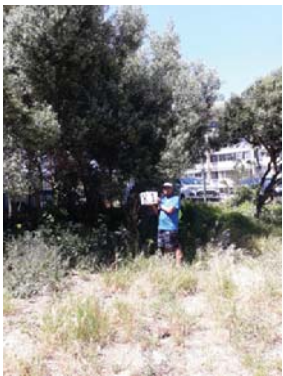
<i>Olea sp.</i>	MS (0.4)	4	5	Requires pruning
82.

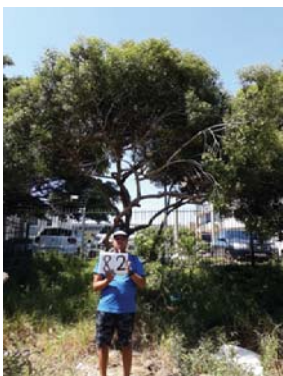
<i>Unknown</i>	0.3	6	5	Split stem, dead wood, requires pruning
83.

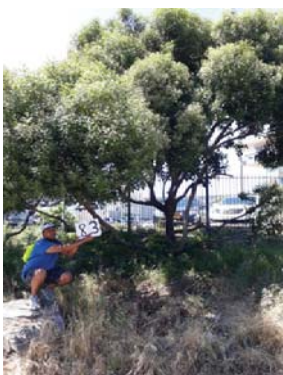
<i>Unknown</i>	MS (0.5)	8	6	spreading, fair condition, requires pruning

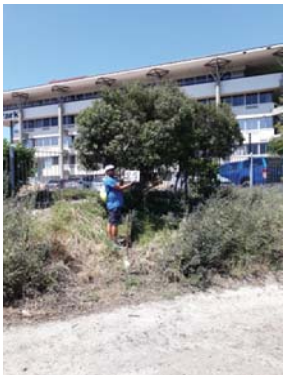
<i>Unknown</i>	0.15	2.5	3	Poor condition, requires pruning
86.

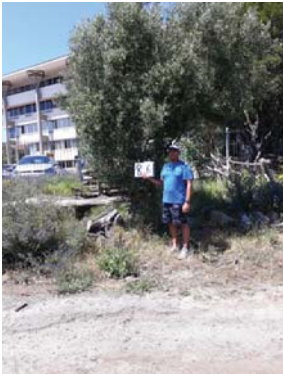
<i>Olea sp.</i>	0.2	5	4.5	Shrub, fair condition, requires pruning

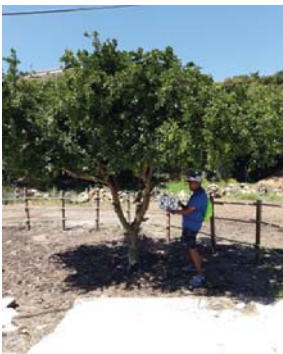
<i>Dovyalis caffra</i>	0.2	6.5	4.5	Shrub, Good condition. Mature
89.

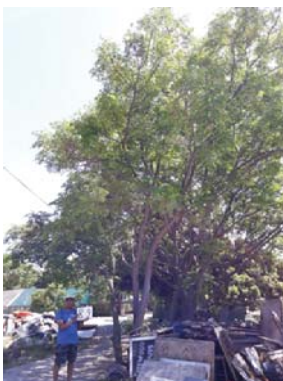
<i>Melia azedarach</i>	0.8	7	12	Cluster, fair condition

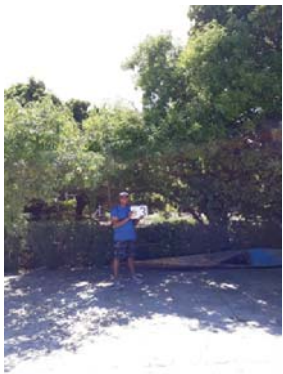
<i>Prunus dulcis</i>	0.3	5	4-5	Mature, fair condition, fruiting, requires pruning
94.

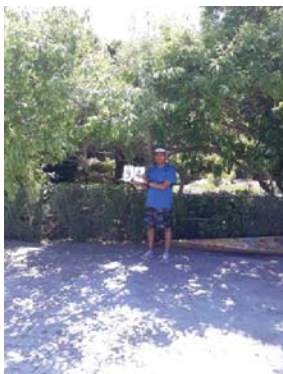
<i>Prunus dulcis</i>	0.2	4.5	4	Mature, fair condition, fruiting, requires pruning
95.

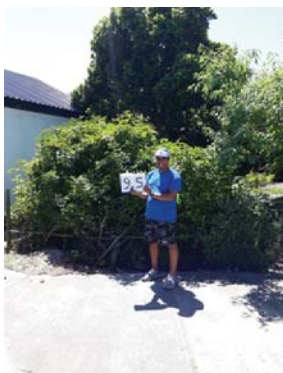
<i>Rosa canina</i>		2	7	Mature, good condition

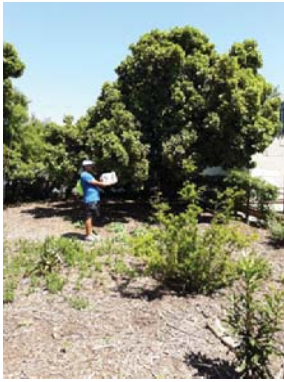
<i>Syzygium cordatum</i>	0.4	9	10	Fair condition, requires pruning
97.

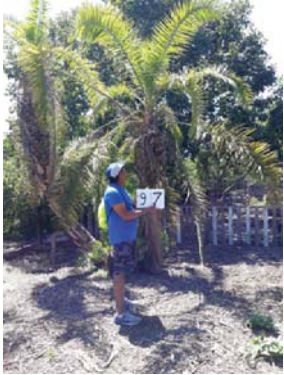
<i>Phoenix reclinata</i>	MS (1.1)	4	4	Poor condition
98.

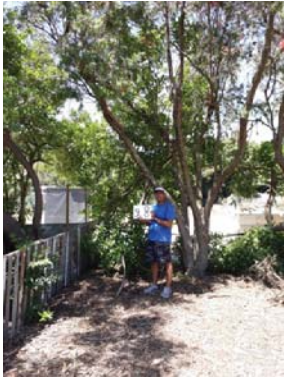
<i>Citharexylum spinosum</i>	MS (1)	2	4	Cluster, poor condition.

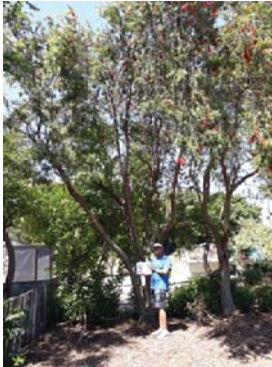
<i>Callistemon viminalis</i>	0.4	5	10	Split stem
100.

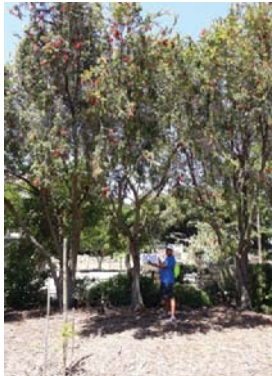
<i>Callistemon viminalis</i>	0.5	5	10	Split stem
101.

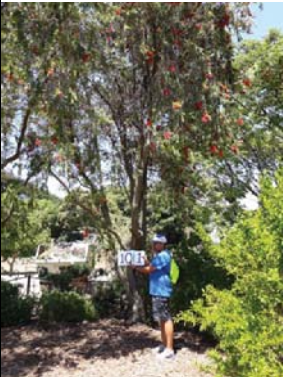
<i>Callistemon viminalis</i>	0.6	5	10	Split stem

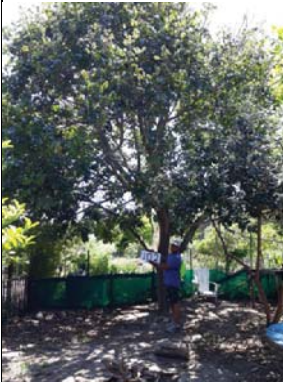
<i>Trichilia emetica</i>	0.4	10	13	Leaning stem, good condition
103.

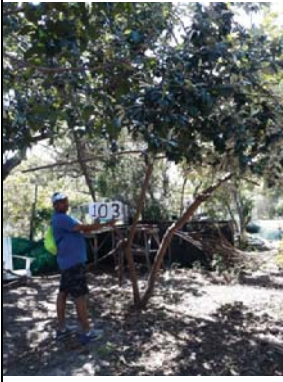
<i>Tarchonanthus camphoratus</i>	0.2	5	4	Leaning stem, spreading
104.

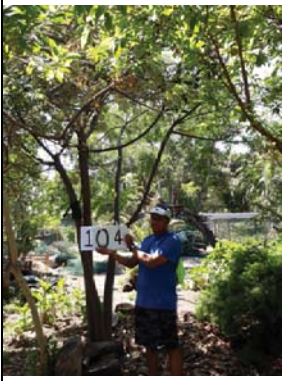
<i>Melia azedarach</i>	0.3	5	4	Fair condition, untidy, shrubs

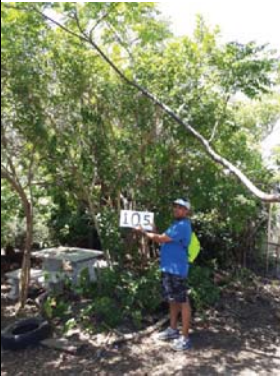
<ul style="list-style-type: none"> -<i>Eriobotrya japonica</i> -<i>Citharexylum spinosum</i> -<i>Liquidambar styraciflua</i> -<i>Schinus terebinthifolius</i> -<i>Persea americana</i> 		7	4-5	Poor condition, shrubs
106.

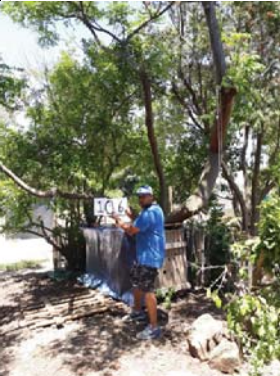
<p><i>Melia azedarach</i></p>	0.45	5	9	Fair condition

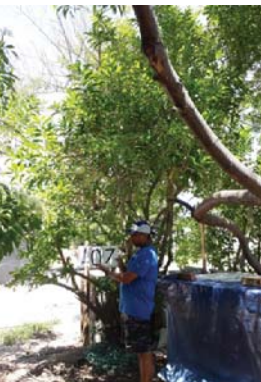
<i>Citharexylum spinosum</i>	MS (0.8)	3.5	4.5	Poor condition, shrub
108.

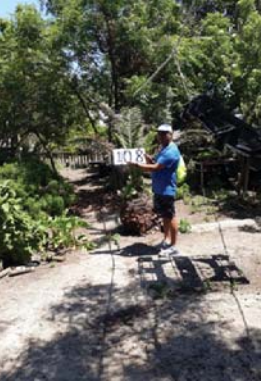
<i>Phoenix canariensis</i>	1	2	2	Clear stem, few branches, poor conditions
109.

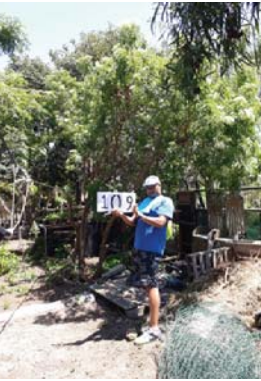
<i>Citharexylum spinosum</i>	MS (1)	4	4.5	Poor condition, shrubs.

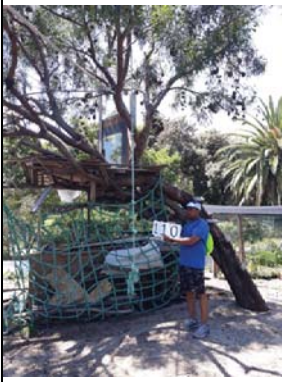
<i>Acacia saligna</i>	0.45	9	9	Leaning, invader
111.	 	<i>Celtis sp. #1</i>	0.25	4	5.2	Big leaves
112.

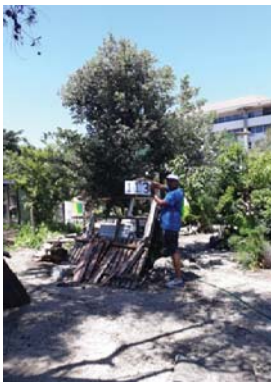
<i>Tarchonanthus camphoratus</i>	0.7	4	5.5	Spreading, fair condition
114.

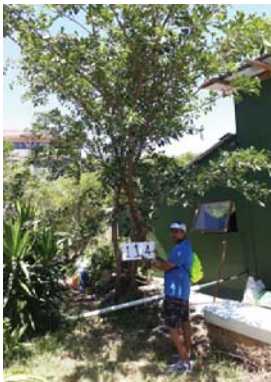
<i>Ficus sp.</i>	MS (1)	5	6.5	Fair condition
115.

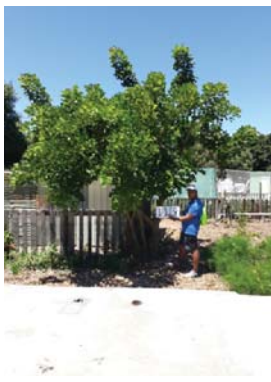
<i>Erythrina sp.</i>	MS	4.5	5.5	Good condition
120.

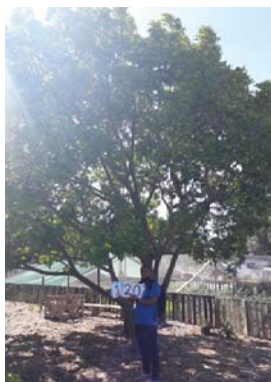
<i>Harpephyllum</i>	MS (1)	10	11	Spreading canopy, good condition
121.

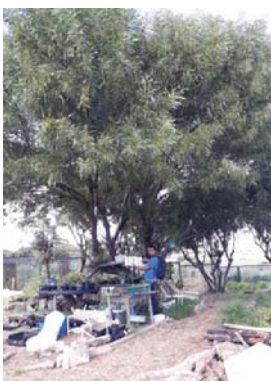
<i>Acacia saligna</i>	0.4	11	9	Leaning, invader, Good condition

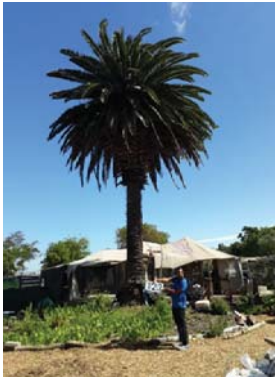
<i>Phoenix canariensis</i>	1.5	7	15	Clear stem, Good condition, requires prune
124.

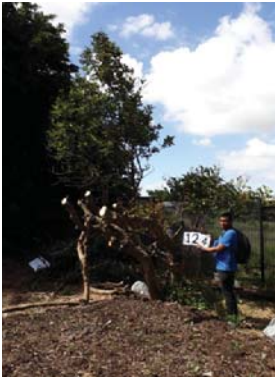
<i>Ceratonia siliqua</i>	0.5	4	5	Multi stem, leaning, heavily pruned, mature

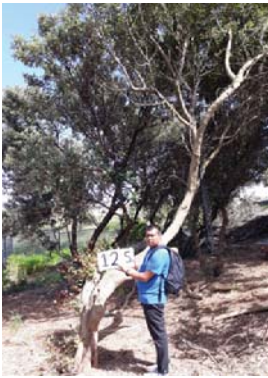
<i>Ceratonia siliqua</i>	0.3	5	6	Wind blown, leaning, dead wood, fair condition
126.

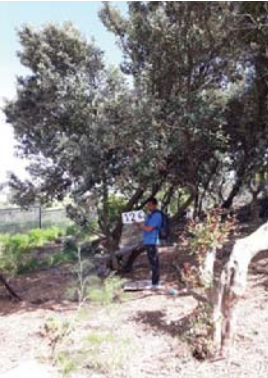
<i>Brachylaena discolor</i> x 6	0.4	15	5	Multi stem, clustered, leaning, wind blown
127.

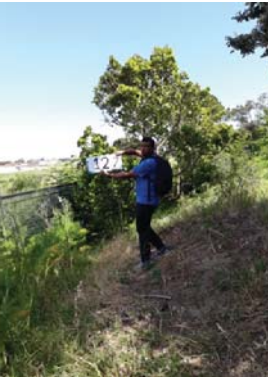
<i>Syzygium cordatum</i> x 3	0.5	10	5	Split stem, wind blown, dead wood, fair condition

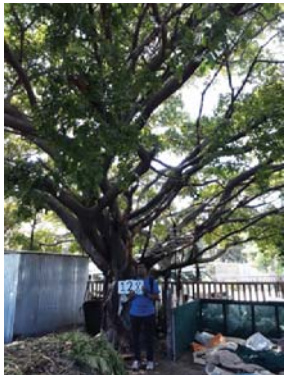
<i>Ficus sp.</i>	2	19	10+	Spreading canopy, good condition
129.

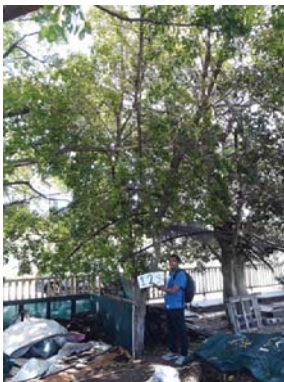
<i>Ficus macrocarpa</i>	0.3	4	8	Supressed growth, fair condition
130.

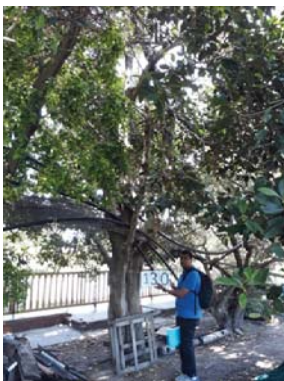
<i>Ficus nataliensis</i>	0.6	9	10+	Damaged, dead wood, fair condition

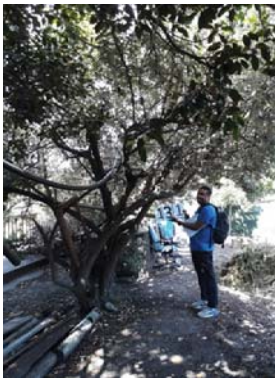
<i>Brachylaena a discolor</i>	MS (1)	9	5	Mature, good condition
132.

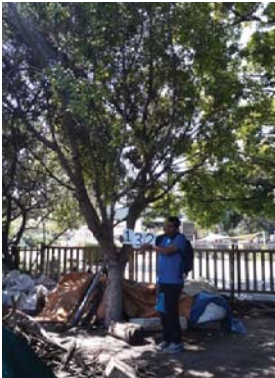
<i>Ficus macrocarpa</i>	0.35	10	9	Damaged, dead wood, Supressed growth
133.

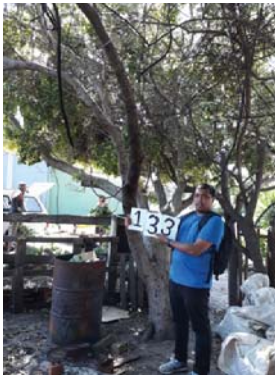
<i>Ficus macrocarpa</i>	0.4	10	9	Damaged, dead wood, Supressed growth,

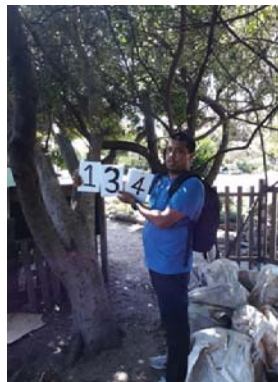
<i>Brachylaena a</i>	6.2	4	5	Fair condition, leaning
135.

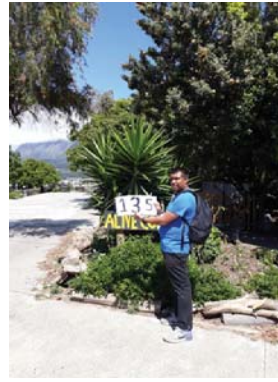
<i>Yucca gigantea</i>				Good condition
136.

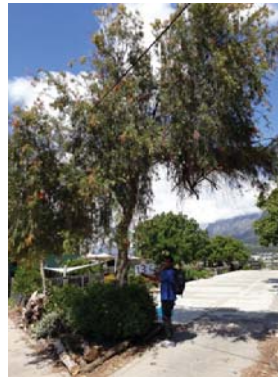
<i>Callistemon viminalis</i>	0.3	5.5	9	Old, damaged, dead wood

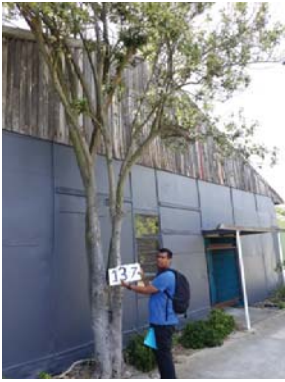
<i>Unknown</i>	0.5	7	10	Old, dead wood, fair condition
138.

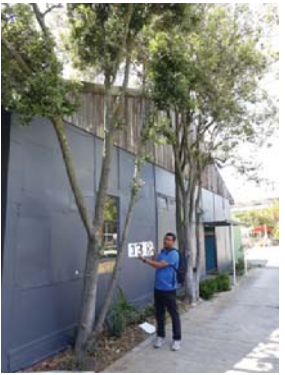
<i>Kiggerlaria africana</i>	0.4	5	10	Fair condition, dead wood
139.

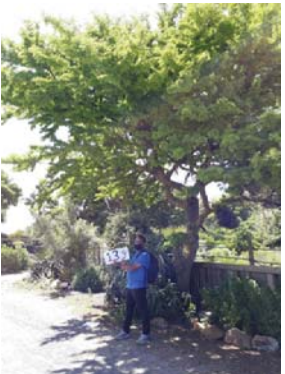
<i>Acacia karoo</i>	0.45	10	8.9	Mature, fair condition

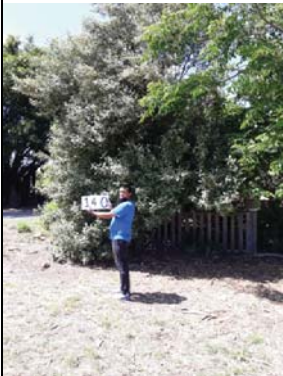
<i>Lagunaria patersonii</i>	0.2	5	7	Dead wood, good condition, requires pruning
141.

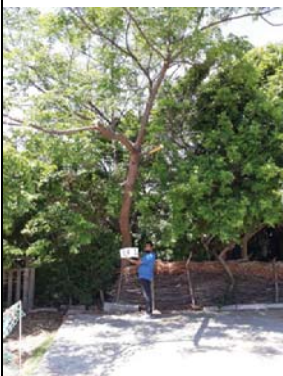
<i>Melia azedarach</i>	0.5	5	10	Fair condition, invader
142.

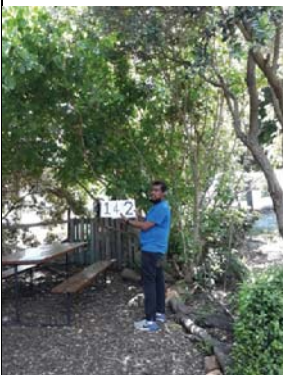
<i>Acer negundo</i>	0.6	6	6	Spreading, poor condition, fair condition, dead wood, damaged

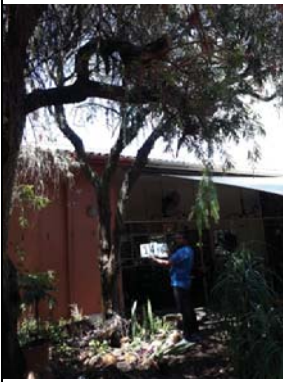
<i>Callistemon viminalis</i>	0.35	7	10	Fair condition, dead wood
147.

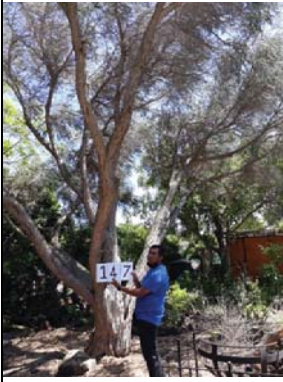
<i>Melaleuca quinquenervia</i>	1	1.3	8-9	Multi stems, mature, spreading, good condition
148.

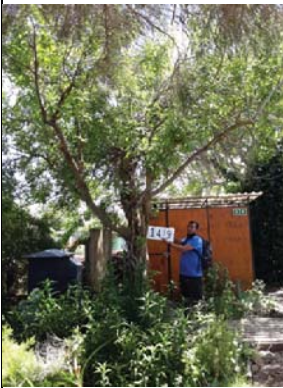
<i>Unknown</i>	0.35	8	8-9	Leaning canopy, dead wood, fair-poor condition
150

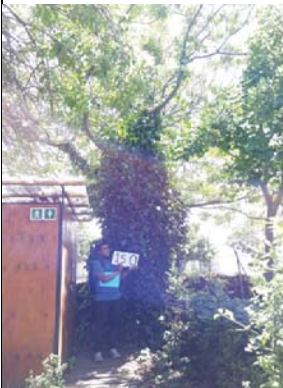
<i>Melia sp.</i>	0.45	6	10-11	Fair condition, invader
151.

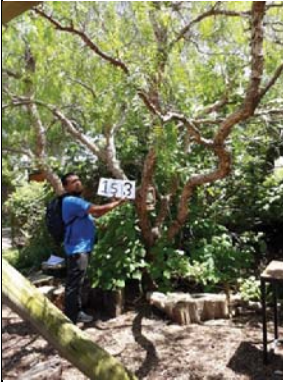
<i>Schinus molle</i>	0.35	8	4.5-5	Fair condition, mature
154.

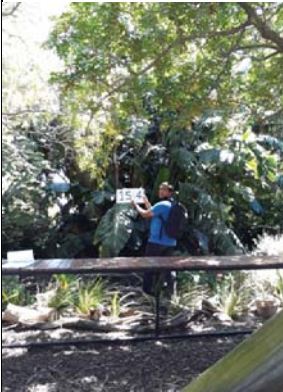
<i>Strelitzia nicolai</i>	MS (3)	7	6	Cluster, good condition

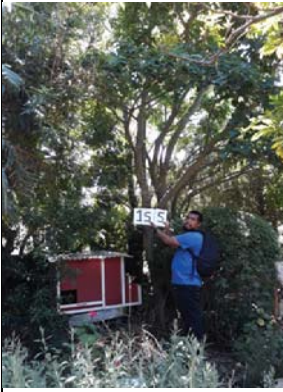
<i>Erythrina sp.</i>	0.5	7	9	Split stem, good condition, dead wood
156.

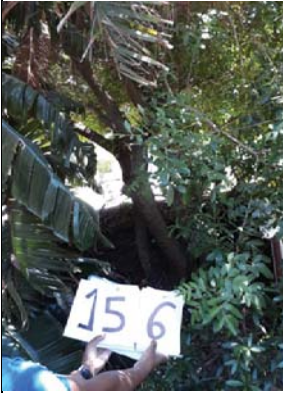
<i>Schinus terebinthifolia</i>	MS (1)	10	9	Fair condition, invader
157.

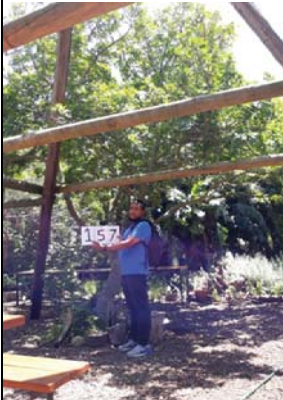
<i>Ekebergia capensis</i>	0.3	8	6	Spreading, good condition

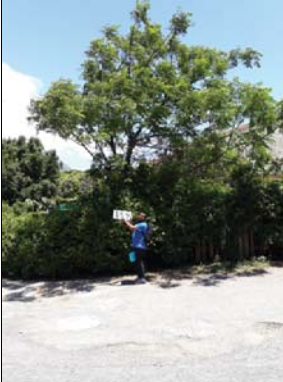
<i>Melia azedarach</i>	0.4	9	9-10	Fair condition, invader
160.

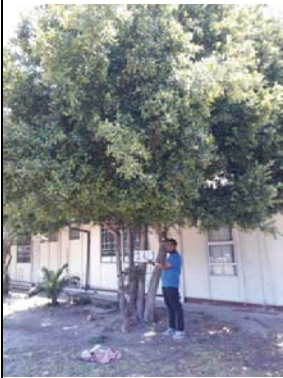
<i>Syzygium paniculatum</i>	1.1	10	7-8	Multi stem, spreading, fair condition
162.

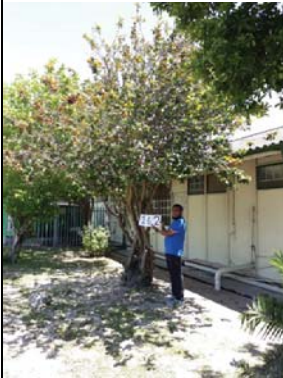
<i>Hibiscus sp.</i>	MS (0.7)	6	5	Fair condition, require pruning
163.

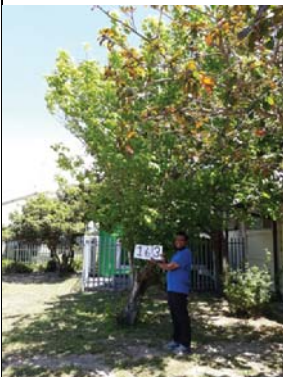
<i>Acer negundo</i>	0.4	5	7	Poor condition, damage

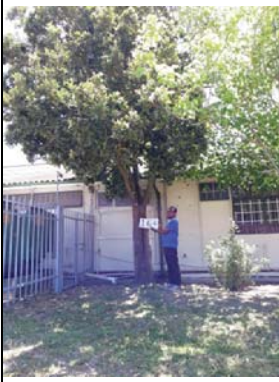
<i>Syzygium cordatum</i>	0.4	5	8	Good condition
165.

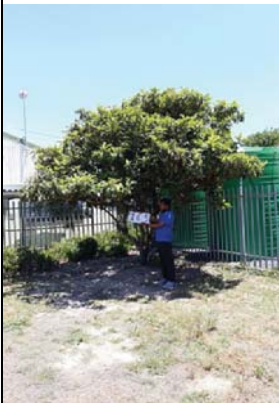
<i>Eriobotrya japonica</i>	MS (0.3)	8	4.5	Spreading, dead wood, fair condition
166.	 	<i>Citharexylum spinosum</i>	MS (0.3)	5	5	Shrub

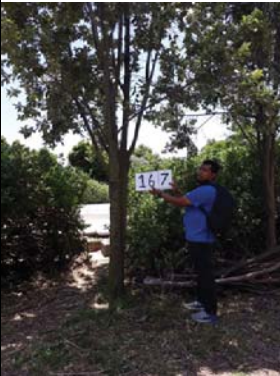
<i>Kiggerlaria africana</i>	0.3	3	7	Good condition
168.

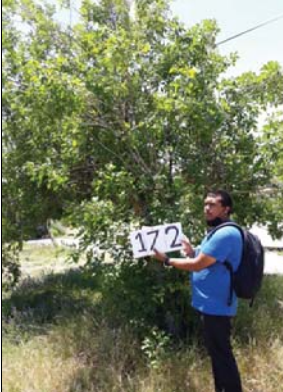
<i>Unknown</i>	0.4	10	5	Canopy blown over, Fair condition

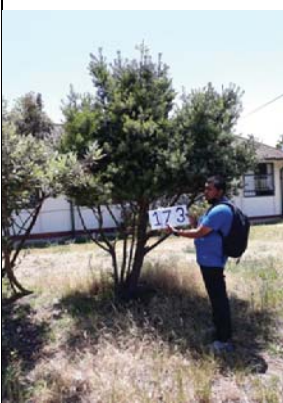
<i>Afrocarpus falcatus</i>	0.4	2.5	4	Multi stem, fair condition
174.

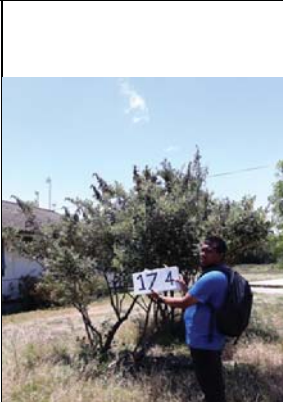
<i>Brachylaena discolor</i>	1	4	3	Multi stem, fair condition
175.

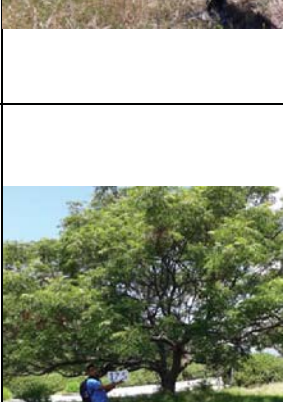
<i>Melia azedarach</i>	1	16	7	Split stem, large..., good condition, invader

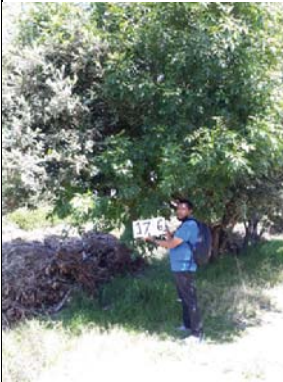
A photograph showing a person in a blue shirt and dark pants standing next to a tree, holding a white sign with the number 176. The tree is leaning to the right.	<i>Unknown</i>	0.3	5	9	Leaning
177.

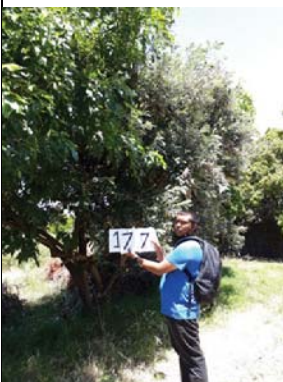
A photograph showing a person in a blue shirt and dark pants standing next to a tree, holding a white sign with the number 177. The tree is spreading and appears healthy.	<i>Brachylaena discolor</i>	MS (1)	11	5	Spreading..., good condition
178.

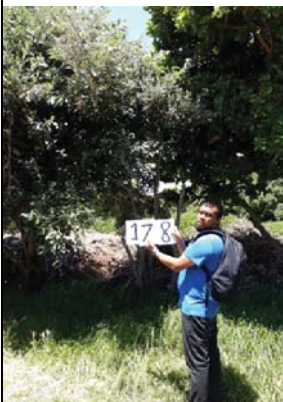
A photograph showing a person in a blue shirt and dark pants standing next to a tree, holding a white sign with the number 178. The tree is dead.	<i>Dead</i>

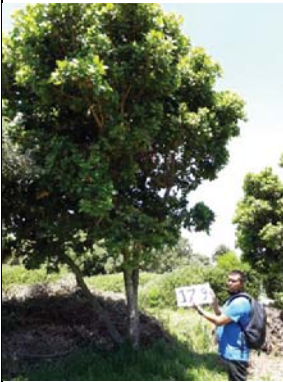
<i>Syzygium cordatum</i>	0.4	4	8	Split stem, fair condition
180.

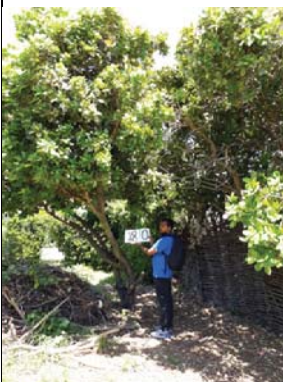
<i>Syzygium cordatum</i>	0.4	4	8	Leaning
181.

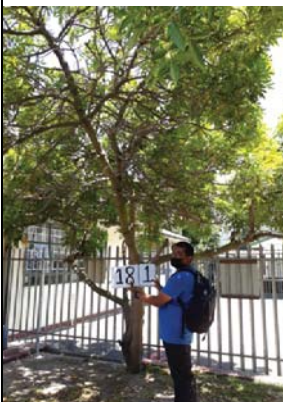
<i>Ekebergia sp.</i>	0.3	10	6	Split stem, fair condition, dead wood

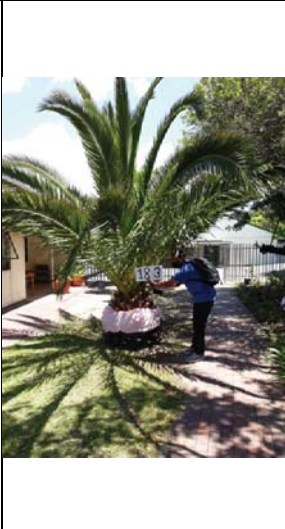
<i>Phoenix canariensis</i>	1	9		Good condition
184.

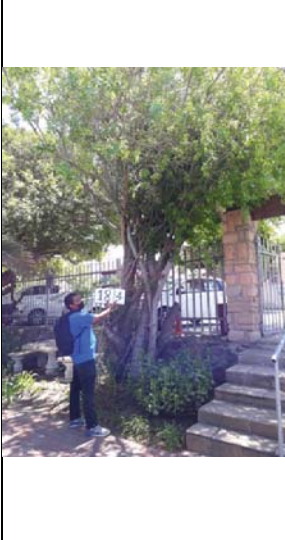
<i>Searsia pendulina</i>	1.5	9-10	9-10

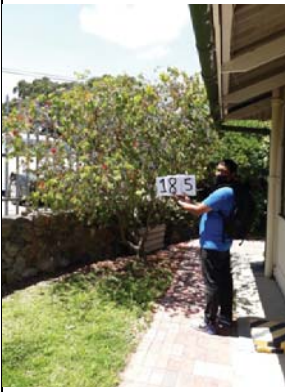
<i>Melaleuca viminalis</i>	0.15	4	3	Shrub
186.

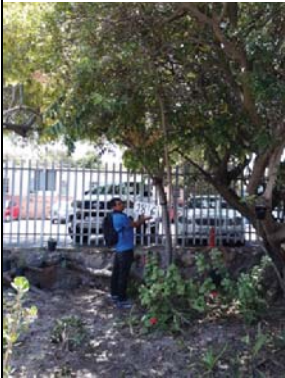
<i>Trichilia emetica</i>	0.3	5	6	Suppress growth, spreading, poor condition
187.

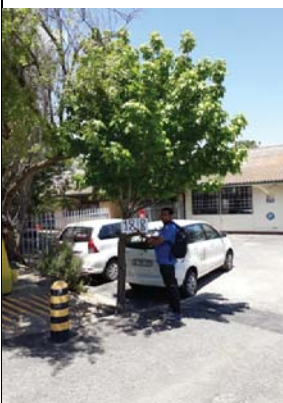
<i>Liquidambar styraciflua</i>	0.25	4	5	Fair condition, damaged by pruning
189.

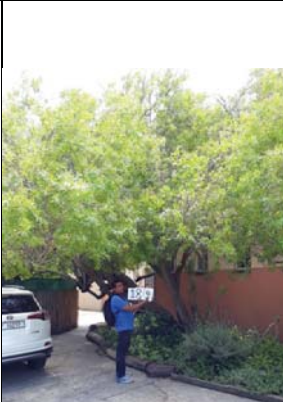
<i>Searsia pendulina</i>	MS (1)			187
190.

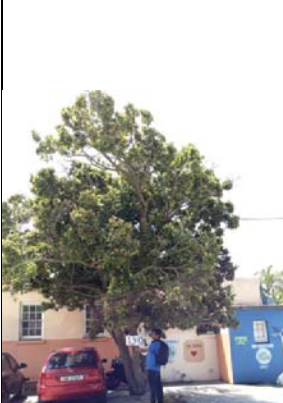
<i>Syzygium cordatum</i>	0.9	9	10-11	Multi stem, dead wood,

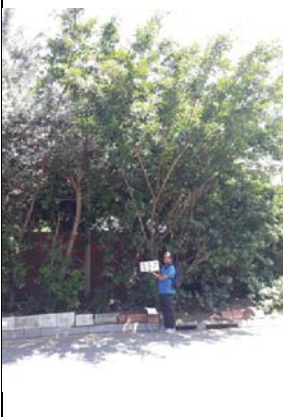
<i>Ficus sp.</i>		1	10-12	Cluster, suppressed growth
198.

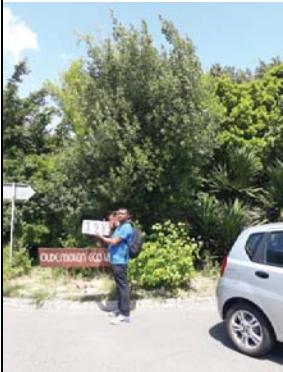
<i>Kiggerlaria africana</i>	0.3	4	6	Over grown, good condition
199.

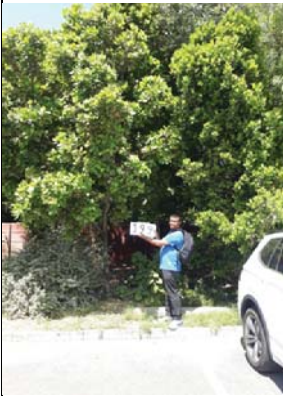
<i>syzygium cordatum</i>	0.4	5	6-7	Fair condition

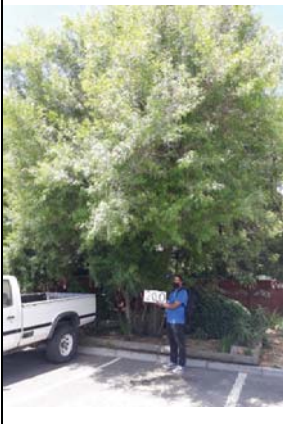
<i>Searsia pendulina</i>	0.5	9	10-12	Fair condition
201.

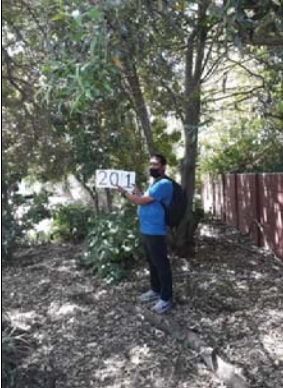
<i>Lagunaria patersonii</i>	0.9	7	10-12	Good condition, slightly suppressed, multi stem
202.

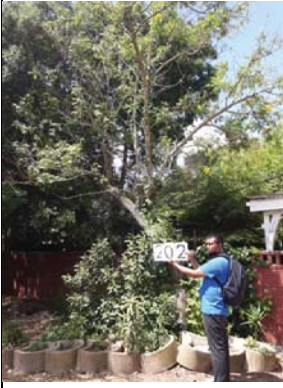
<i>Tecoma stans</i>	0.8	7	9	Poor condition, dead wood

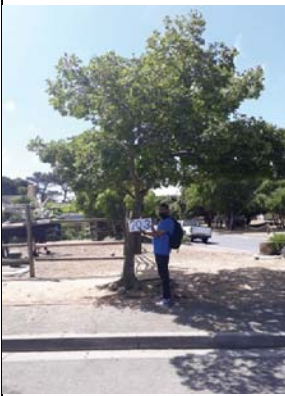
<i>Celtis sp.</i>	0.35	7	6	Good condition, exposed roots
204.

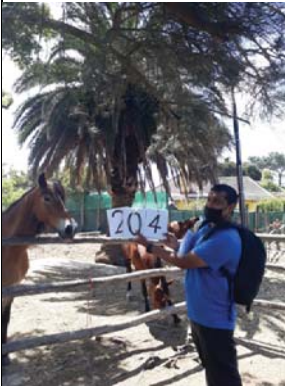
<i>Phoenix canariensis</i>	1.2	7	14	Good condition
205.

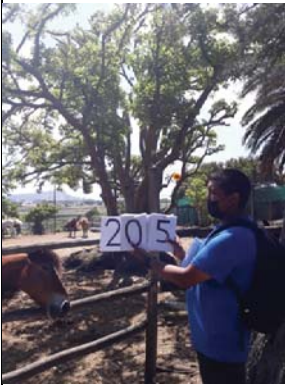
<i>Phytolacca dioica</i>	2.5	7	12	Exposed roots, poor condition, invader

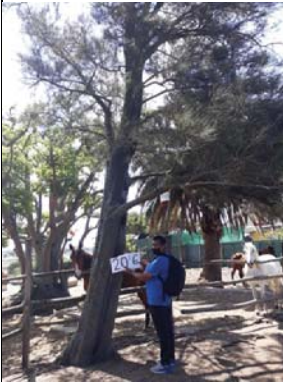
<i>Casuarina cunninghamiana</i>	0.8	8	13	Invader, poor condition, dead wood,
207.

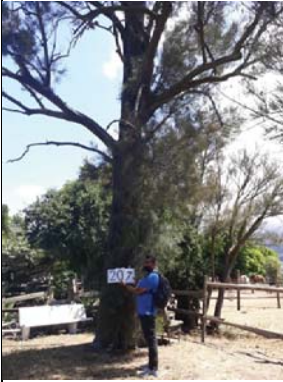
<i>Casuarina cunninghamiana</i>	0.8	8	14	
208.

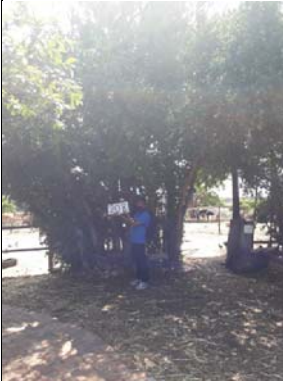
<i>Dovyalis caffra</i>	3.2	6	8	Over grown, fair condition

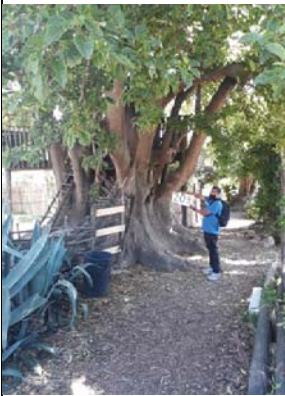
<i>Phytolacca dioica</i>	8	19	12	3 trees growing into each other
210.

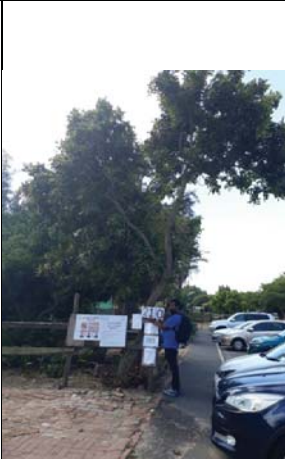
<i>Ceratonia siliqua</i>	1	10	8	Fair condition, leaning over
211.

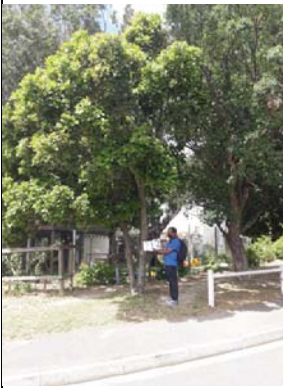
<i>Syzygium cordatum</i>	0.35	7	8	Split stem, good condition
213.

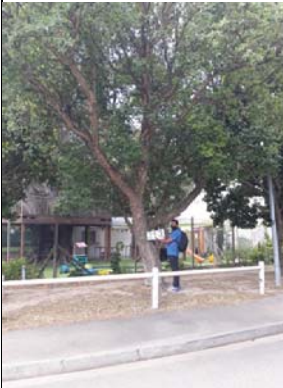
<i>Quercus sp.</i>	0.5	10	12	Good condition
214.

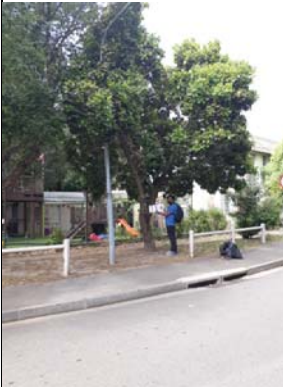
<i>Syzygium cordatum</i>	0.4	11	9	Good condition

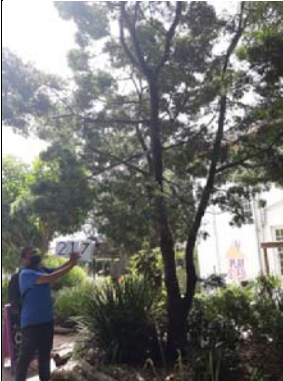
<i>Afrocarpus falcatus</i>	0.4	7	12	Good condition, split stem

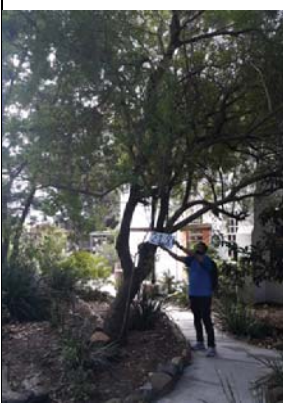
<i>Searsia viminalis</i>	0.4	13	12	Leaning over
219.

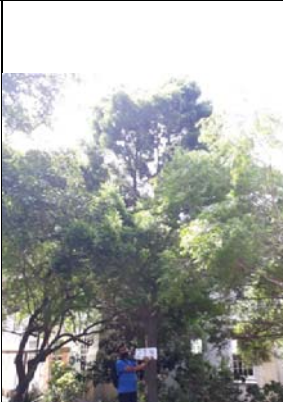
<i>Afrocarpus falcatus</i>	0.4	7	12	No split stem
220.

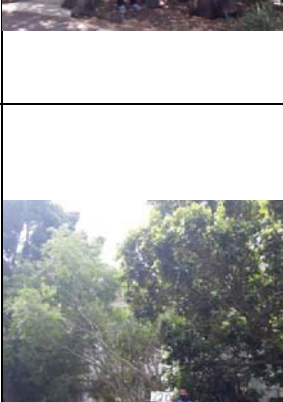
<i>Searsia viminalis</i>	MS (0.8)	7	7	Fair condition, dead wood,

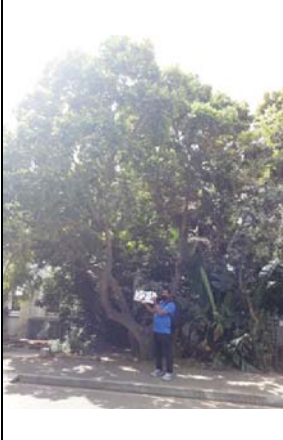
<i>Syzygium cordatum</i>	MS (0.9)	12	12	Good condition, spreading canopy
222.

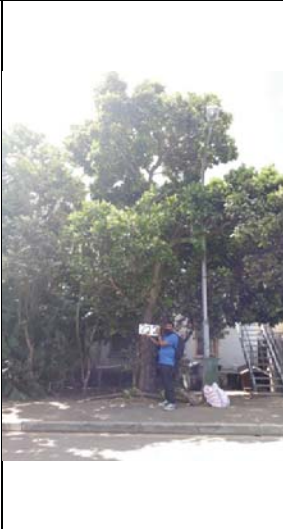
<i>Syzygium cordatum</i>	0.5	9	12	
223.

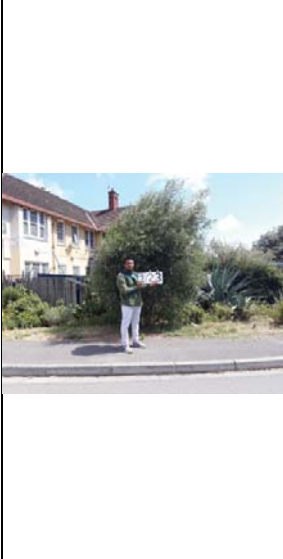
<i>Olea sp.</i>	MS (0.25)	4.5	5.5	Shrub, good condition

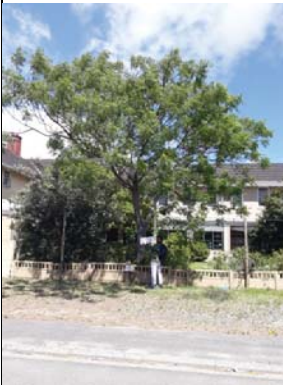
<i>Melia azedarach</i>	0.35	10	12	Good condition, invader

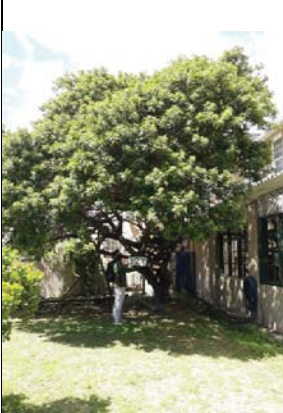
<i>Schinus sp</i>	0.64	10	11	Multi stem, over grown, fair condition
228.

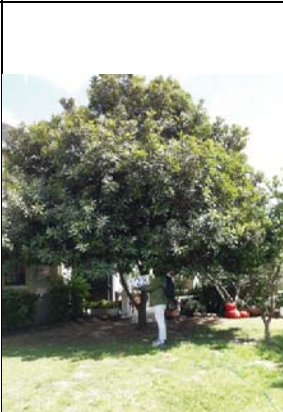
<i>Macadamia integrifolia</i>	0.22	9	11	Good condition, healthy..
229.

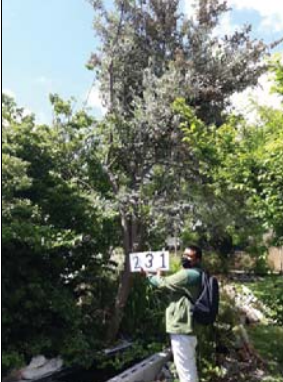
<i>Brachylaena discolor</i>	0.16	5	8	Suppressed growth, fair condition
232.

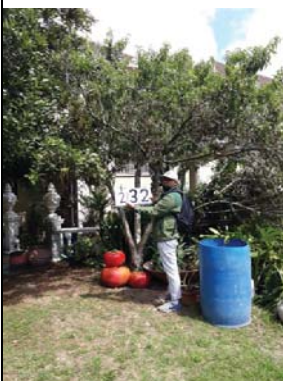
<i>Prunus persica</i>	.3	8	6.5	Stem split, fruiting, fair condition
