Cape Town, Oude Molen Precinct

TREES AND SHRUBS QUALITY SURVEY

Planning Partners
Landscape Architects

Western Cape Government

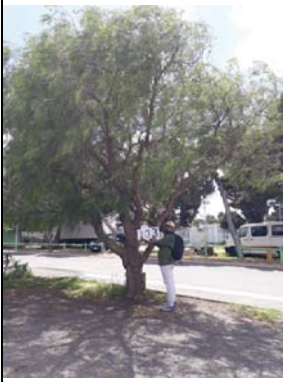
<i>Schinus molle</i>	0.4	13	9	Good condition
234.

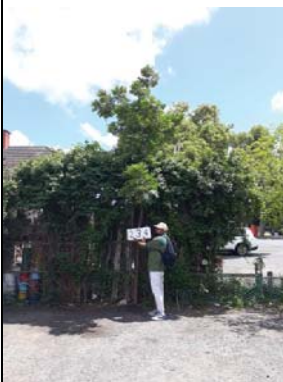
<i>Harpephyllum sp.</i>	0.1	1	5	Upright, good condition, split stem
235.

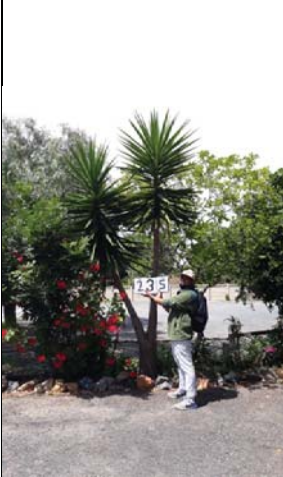
<i>Yucca gigantea</i>	0.24	3	5	Split stem (0.5)

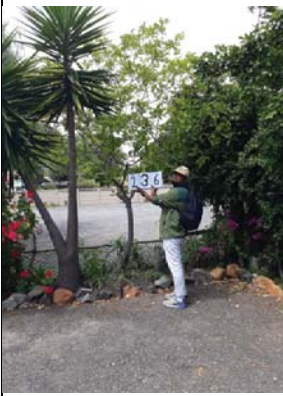
<i>Ceratonia siliqua</i>	0.12	3	5	Leaning, good condition, young
237.

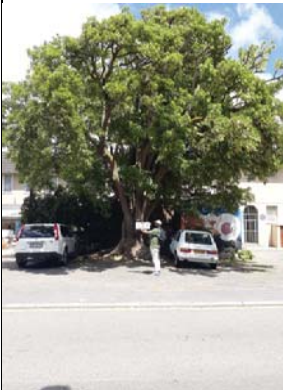
<i>Phytolacca dioica</i>	7	15	13-14	Exposed roots, mature, good condition, invader
238.

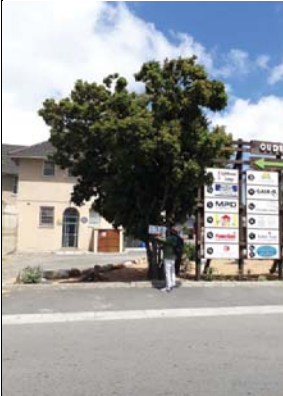
<i>Syzygium cordatum</i>	MS (0.6)	9	11	Good condition

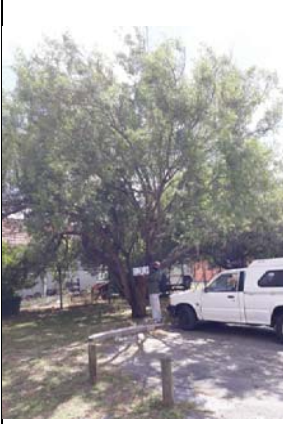
<i>Searsia pendulina</i>	0.4	9	10	Spit stem, good condition
240.

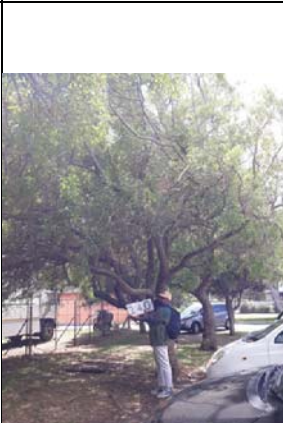
<i>Searsia pendulina</i>	0.4	9	10	Spreading canopy, good condition
241.

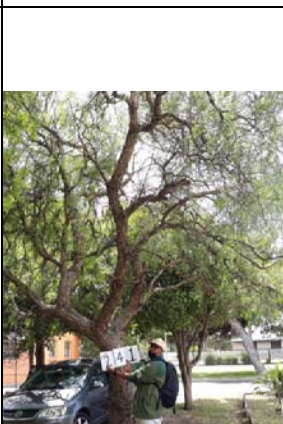
<i>Schinus molle</i>	0.54	7	11	Dead wood, fair condition

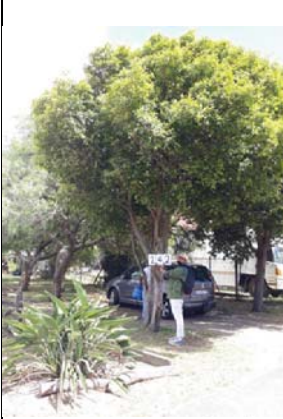
<i>Syzygium paniculatum</i>	0.4	7	11	Split stem, dead wood, fair condition
243.

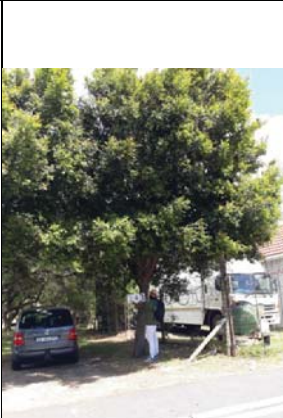
<i>Syzygium paniculatum</i>	0.27	8	22-13	Fair condition
244.

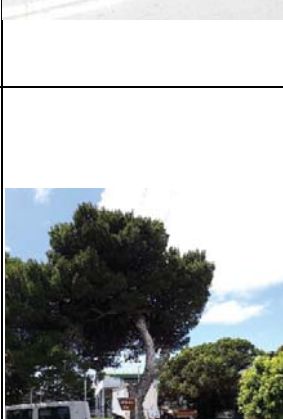
<i>Pine sp.</i>	0.65	12	13	Canopy, dead wood, fair-poor condition

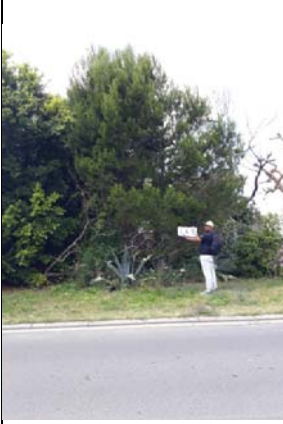
<i>Pine sp.</i>	0.4	7	12	Dead wood, good condition
246.

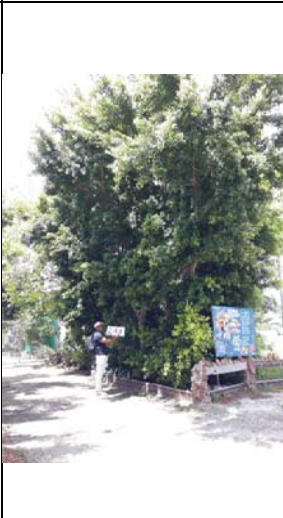
<i>Ficus microcarpa</i>	W (8)	15	11	Good condition, cluster
247.

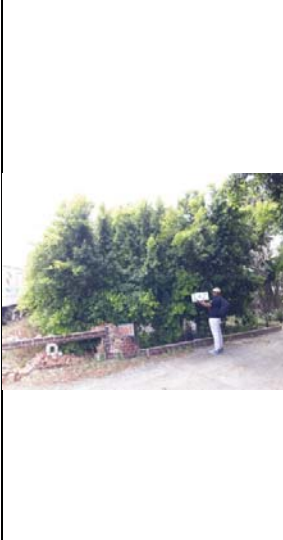
W (11)	11	6	Good condition

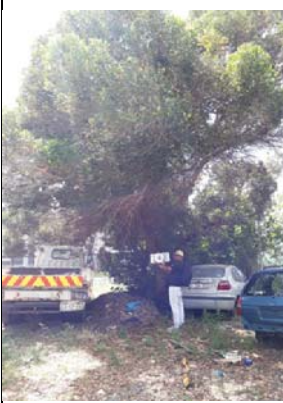
<i>Eucalyptus ficifolia</i>	0.9	15	10	Dead wood, fair condition, mature
249.

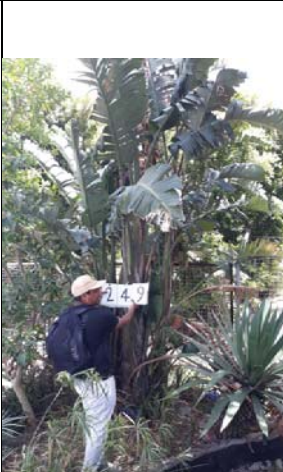
- <i>Strelitzia Nicolai</i> - <i>Citharexylum spinosum</i>		4	8-10	Good condition, cluster
250.

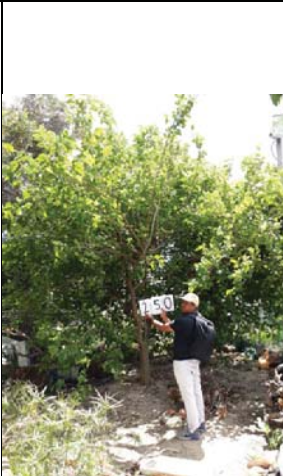
<i>Morus alba</i>	0.3	6	7	Mature, over grown, good condition

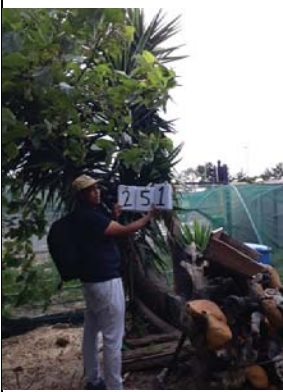
<i>Yucca gigantea</i>	0.4	1.5	6	Good condition
252.

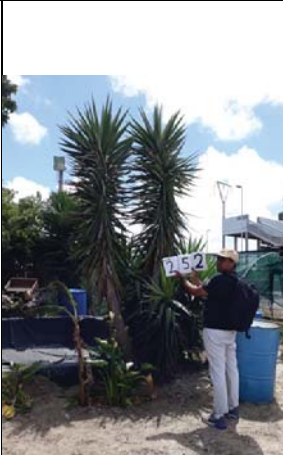
<i>Yucca gigantea</i>	0.4	1.5	6	Good condition
253.	 	<i>Eucalyptus sp.</i>	0.4	10	10	Dead wood, mature, good condition

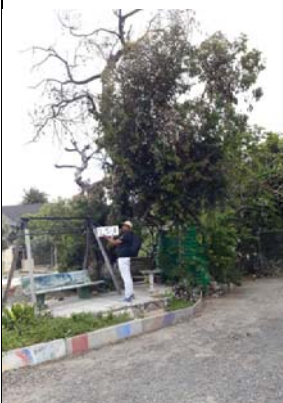
<i>Eucalyptus sp.</i>	0.8	6	10	Half dead, poor condition
255.

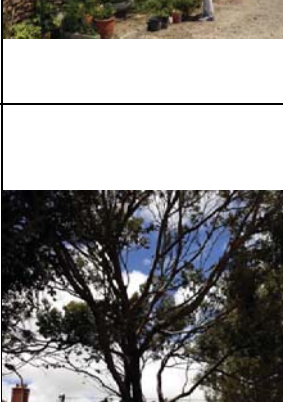
<i>Eucalyptus sp.</i>	MS (1)	12	15	Split stem(1), dead wood, good condition

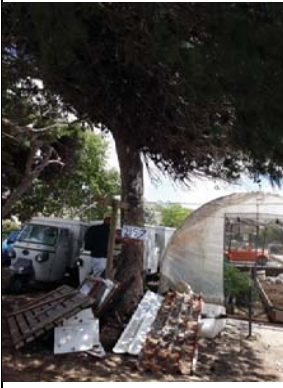
<i>Pine sp.</i>	0.6	5	9	Leaning stem, dead wood, poor condition
258.

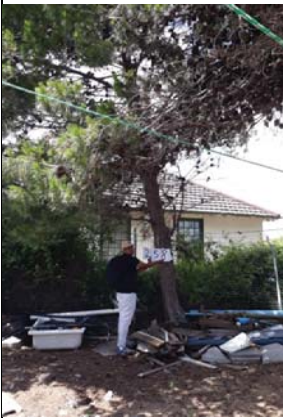
<i>Pine sp.</i>	0.8	7	10	Fair condition, dead wood
259.

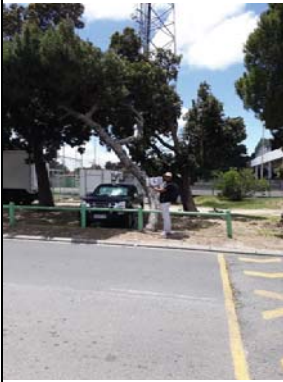
<i>Pine sp.</i>	0.4	7	9	Blown over, poor condition, dead wood
261.

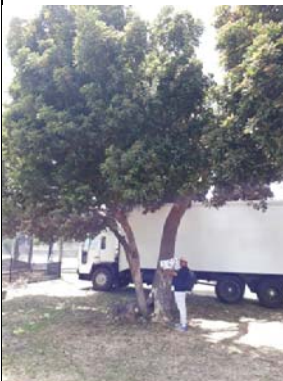
<i>Eucalyptus ficifolia</i>	MS (1)	13	14	Good condition, matures

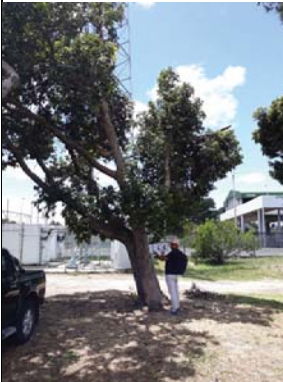
<i>Eucalyptus ficifolia</i>	0.8	12	10	Split stem, dead wood, poor condition
265.

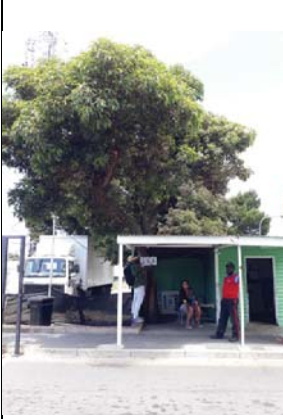
<i>Eucalyptus ficifolia</i>	0.35	6	9	Leaning stem, good condition
267.

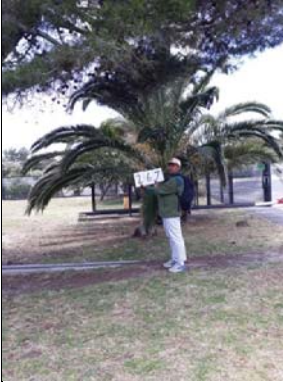
<i>Phoenix canariensis</i>	1.5	9	8	1.5 clear stem, good condition
268.

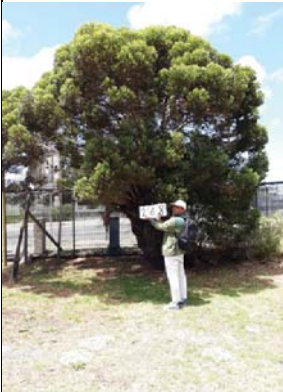
<i>Eucalyptus sp.</i>	0.5	10	9	Fair condition, dead wood

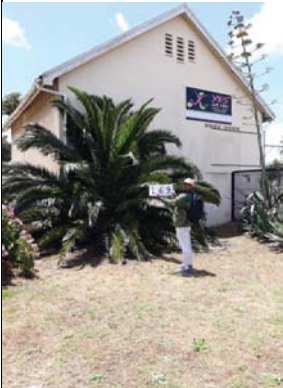
<i>Phoenix sp.</i>	1.2	8	5	Good condition
270.

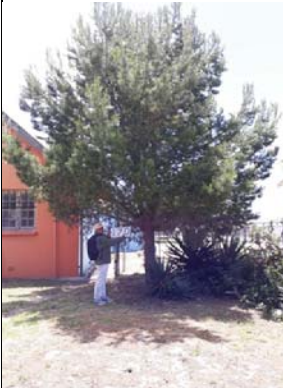
<i>Pine sp.</i>	0.3	9	10	Good condition
271.

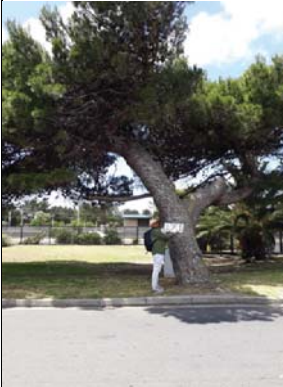
<i>Pine sp.</i>	0.8	17	9-10	Dead wood, canopy blown over

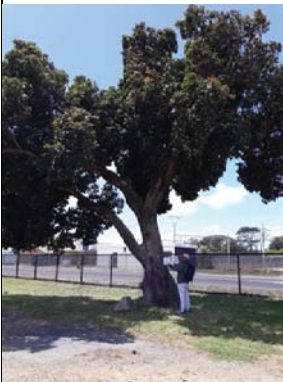
<i>Eucalyptus sp.</i>	1.6	17	13	Mature, good condition
274.

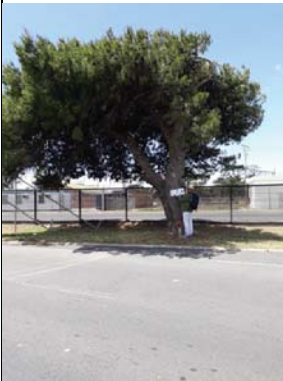
<i>Pine sp.</i>	1.2	17	12	Split stem, mature, dead wood, fair condition

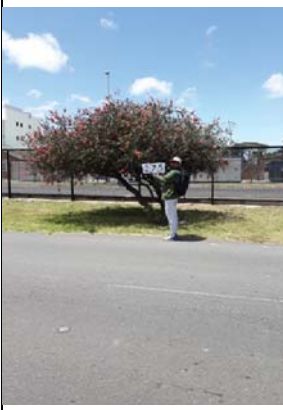
<i>Callistemon sp.</i>	0.9	8	4	Fair-good condition
276.

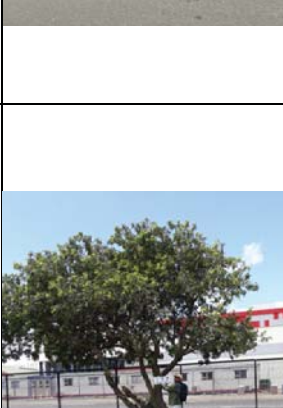
<i>Ceratonia siliqua</i>	MS (1.3)	11	7-8	Fair-good condition,

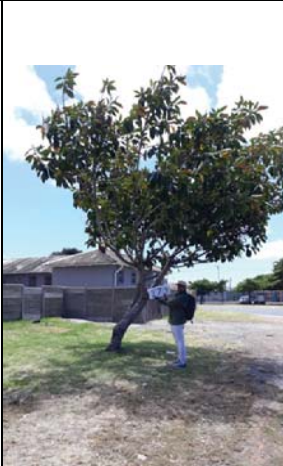
<i>Ficus sp.</i>	MS (1)	6	3	Leaning over, dead wood, good condition
280.

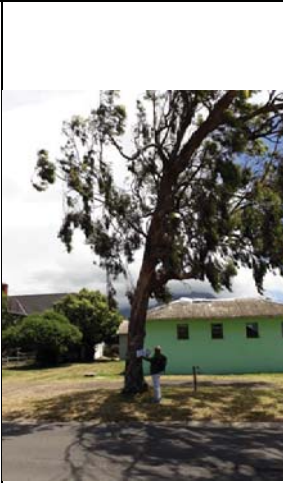
<i>Eucalyptus sp.</i>	0.75	13	13-14	Dead wood, fair condition

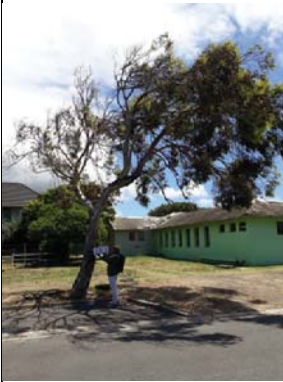
<i>Eucalyptus sp.</i>	0.45	11	7	Dead wood,
282.

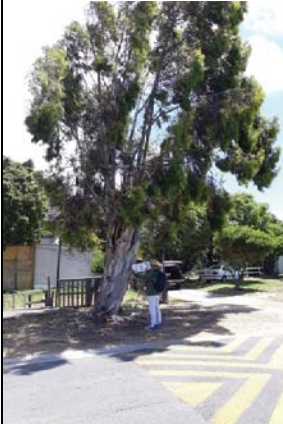
<i>Eucalyptus sp.</i>	0.9	12	10-12	Dead wood
283.

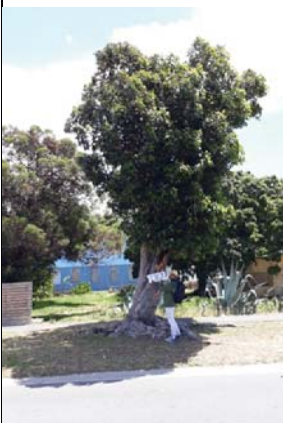
<i>Eucalyptus ficifolia.</i>	0.9	8	10-12	Exposed roots, good condition

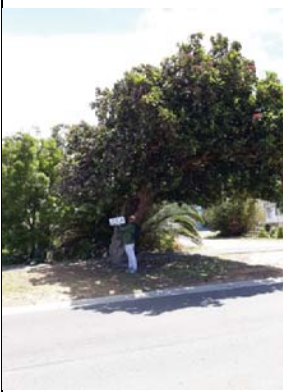
<i>Eucalyptus ficifolia</i>	0.9	11	9	Split stem(1-5), good condition, dead wood
285.

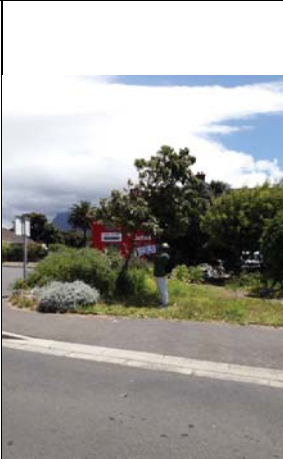
<i>Persea americana.</i>	0.12	2	4.5	Fair condition
286.

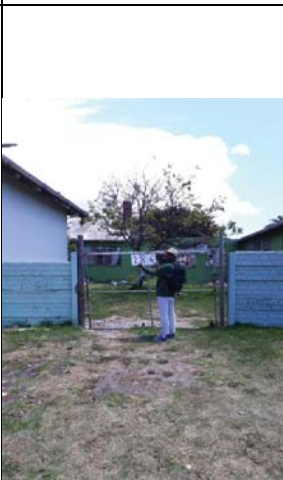
<i>Ceratonia siliqua</i>	0.25	7	8	Poor condition, dead wood

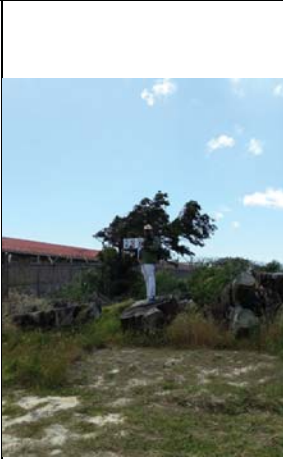
<i>Agonis flexuosa</i>	MS (1)	4.5	5-6	Poor condition,
289.

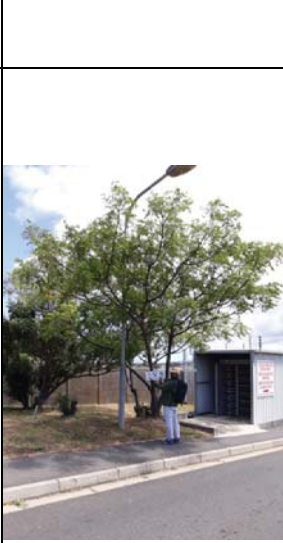
<i>Melia azedarach</i>	MS (0.9)	7	5	Invader, poor conditions

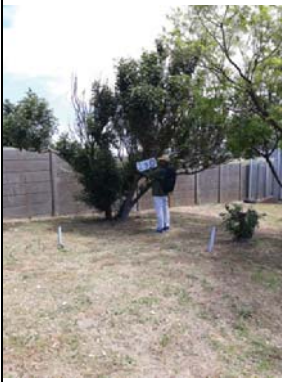
<i>Fraxinus angustifolia</i>	MS (0.75)	8	4.8	Poor condition
291.

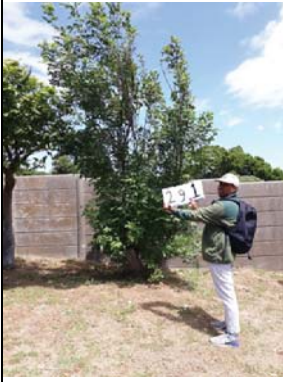
<i>Fraxinus angustifolia</i>	0.6	1.7	3-4	Poor condition, damaged
292.

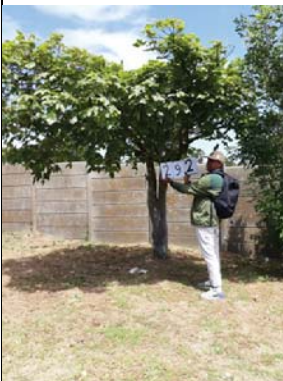
<i>Dombeya rotundifolia</i>	0.3	4	3-4	Fair condition, damaged

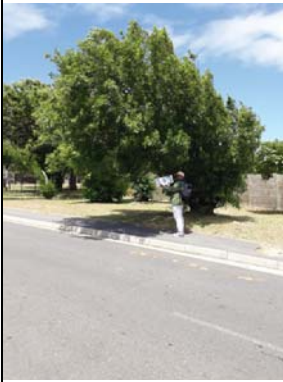
<i>Fraxinus angustifolia</i>	MS (1.4)	6	7-8	Fair condition, damaged by pruning
294.

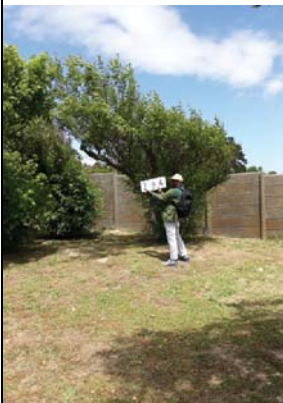
<i>Fraxinus angustifolia</i>	0.6	5	5-6	Poor condition, dead wood
295.

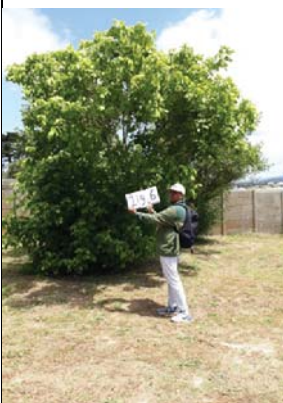
<i>Acer sp.</i>	0.3	5	5-6	Poor condition, damaged by pruning
297.

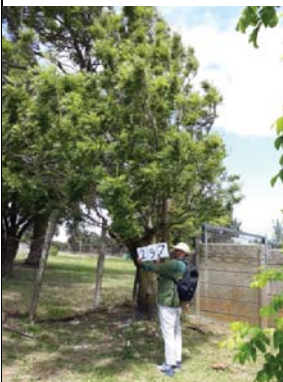
<i>Grevillea striata</i>	0.9	14	9-10	Split stem, spreading canopy, poor condition, dead wood,
298.

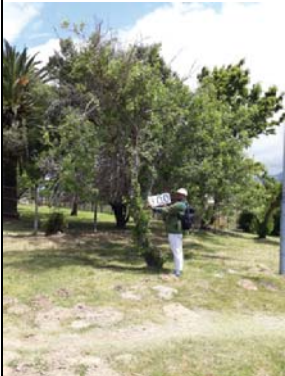
<i>Unknown</i>	0.5	3	5-6	Poor condition, half dead, remove
301.

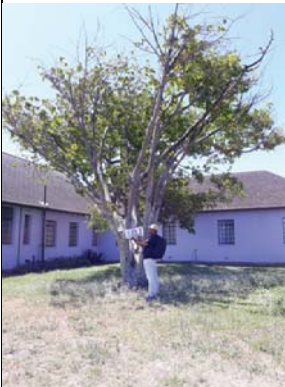
<i>Ficus elastica</i>	MS (0.6)	9	7	Fair condition, wind damage

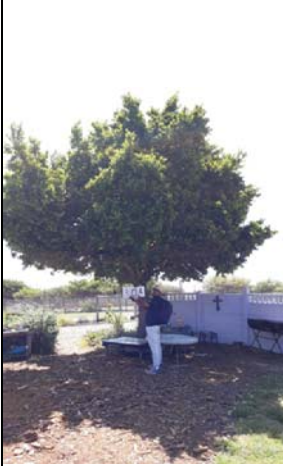
<i>Syzygium paniculatum</i>	0.38	9	11	Good condition

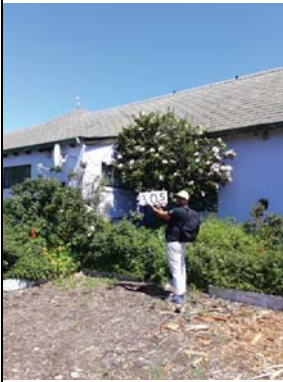
<i>Hibiscus sp.</i>	0.4	4	4.5	Mature shrub, fair condition
306.

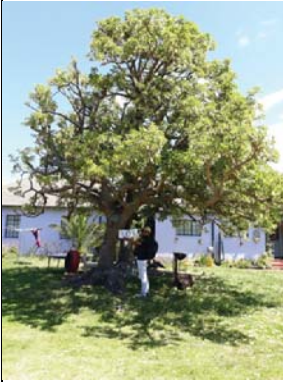
<i>Phytolacca dioica</i>	3	12	10-12	Exposed roots, invader
307.

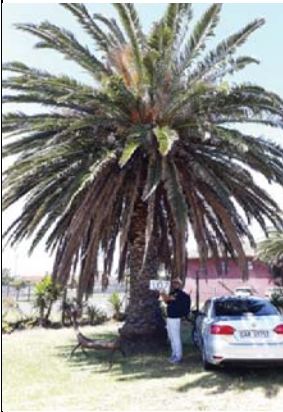
<i>Phoenix canariensis</i>	1.3	9	12	Clear stem(1m), good condition

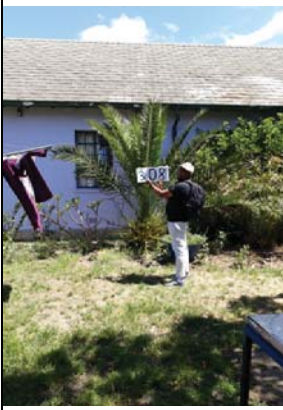
<i>Phoenix canariensis</i>	0.29	2.5	2.5	Good condition, young
309.

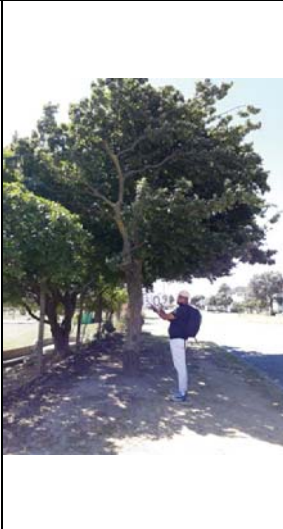
<i>Quercus sp.</i>	0.4	11	8-9	Good condition
310.

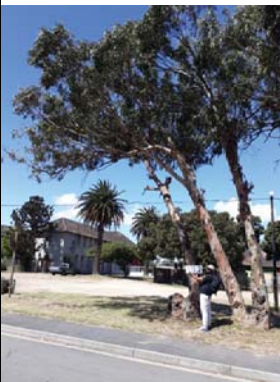
<i>Eucalyptus sp.</i>	1.1	8	10-12	Poor condition, dead wood, enlarged base
313.

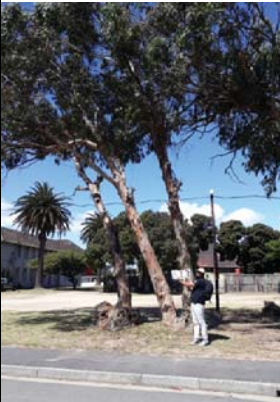
<i>Eucalyptus sp.</i>	1.1	10	10-12	Split stem, dead wood, fair condition

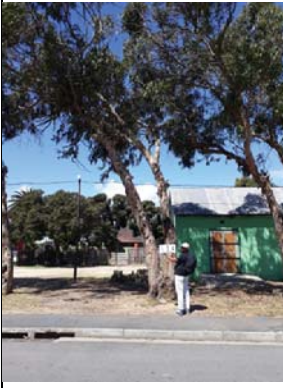
<i>Eucalyptus sp.</i>	1.1	10	10-12	Fair condition, dead wood
315.

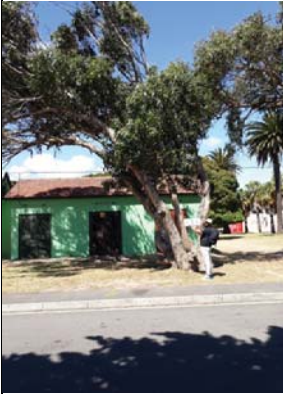
<i>Eucalyptus sp.</i>	MS (1.9)	17	10-12	Poor condition-fair condition, dead wood

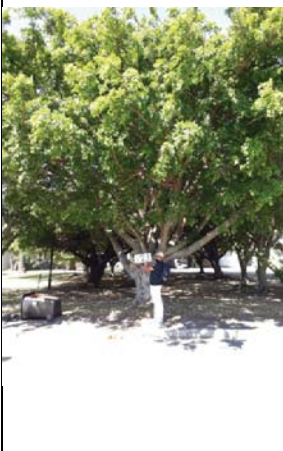
<i>Ficus sp.</i>	1.1	24		Exposed roots, good condition
322.

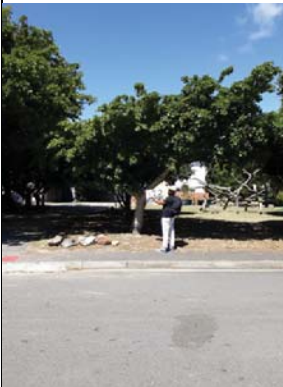
<i>Ficus sp.</i>	0.3	11	6	Good condition

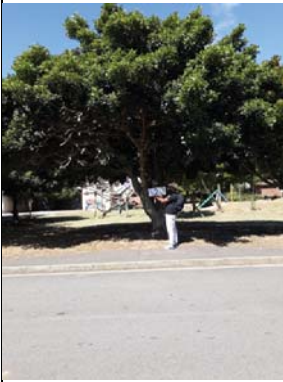
<i>Ficus sp.</i>	0.6	11	8	Good condition
324.

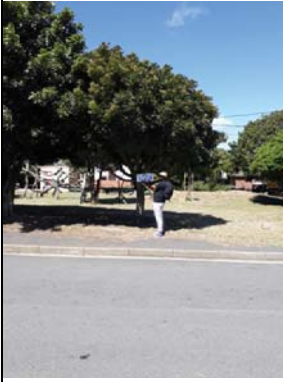
<i>Ekebergia sp.</i>	0.25	6	7	Good condition
325.

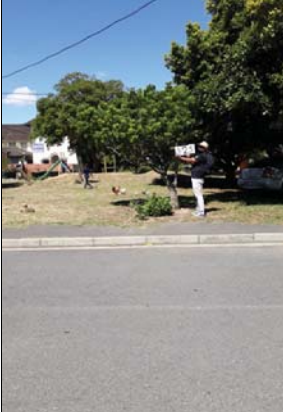
<i>Ekebergia sp.</i>	0.2	4	4.5	Stunted growth,

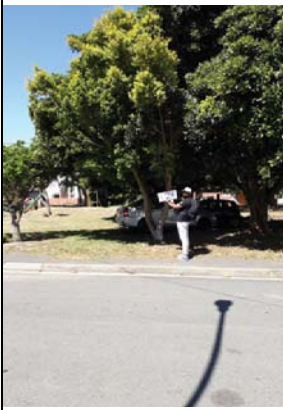
<i>Ficus sp.</i>	0.38	7	6-7	Split stem(0.5), good condition
327.

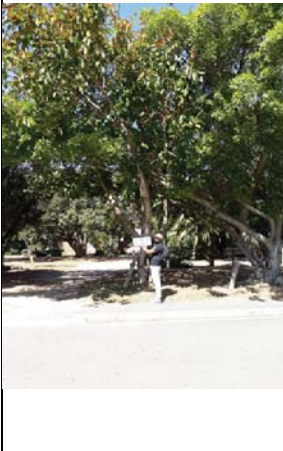
<i>Ficus sp. x2</i>	1.2	8	10	Good condition
328.

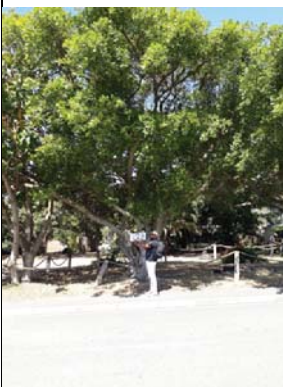
<i>Ficus microcarpa</i>	1.3	2.5	10	Good condition, spreading canopy

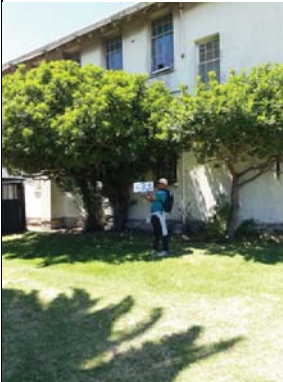
<i>Yucca gigantea</i>	1.5	3.5	10	Enlarged base, very tall yaccu
336.

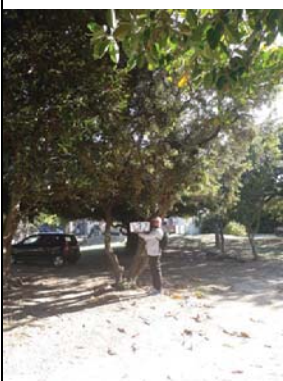
<i>Brachylaena discolor</i>	MS (0.8)	7	8	Fair condition-poor condition dead wood, requires pruning

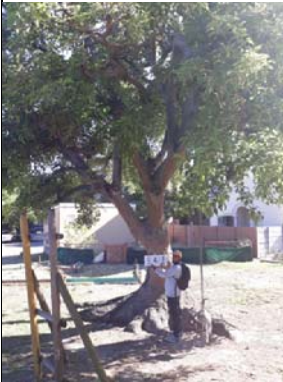
<i>Phytolacca dioica</i>	5	13	10-11	Enlarged base, good condition, invader
342.

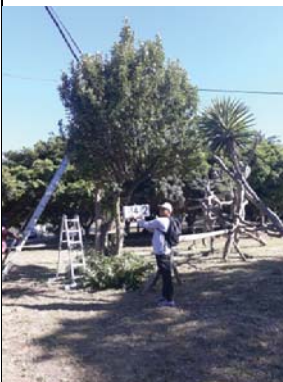
<i>Kiggerlaria africana</i>	MS (0.5)	3.5	7-8	Fair condition, damaged by pruning
343.

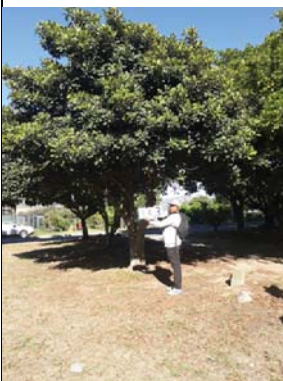
<i>Ficus natalensis</i>	0.43	9	8-9	Good condition

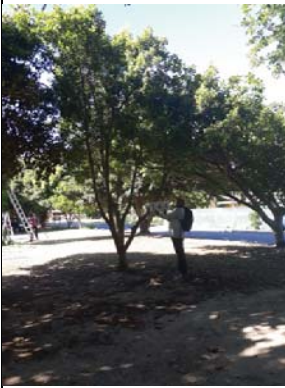
<i>Ficus microcarpa</i>	0.22	5	7-8	Good condition, suppressed growth
345.

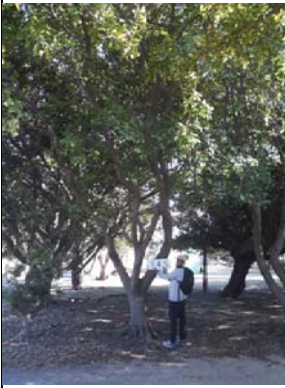
<i>Ficus sp.</i>	0.5	11	9-10	Good condition
346.

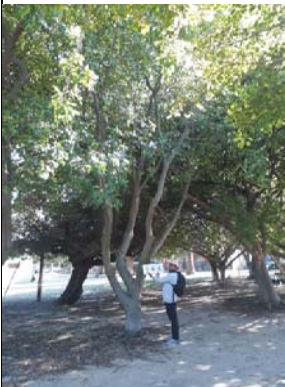
<i>Ficus sp.</i>	0.5	11	9-10	Good condition

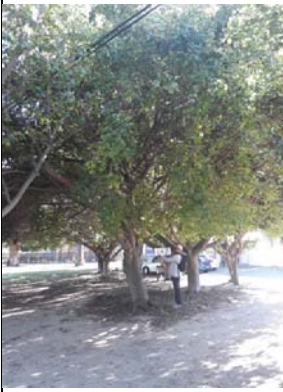
<i>Ficus sp.</i>	0.7	10	10-11	Leaning stem, good condition
348.

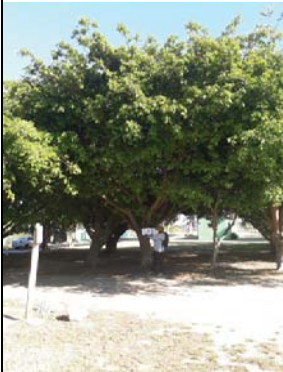
<i>Ficus sp.</i>	0.7	10	10-11	Good condition
349.

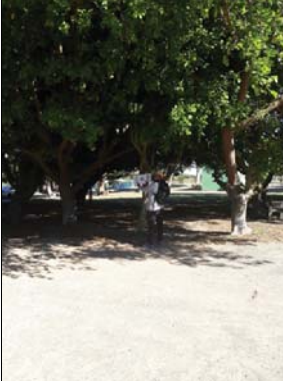
<i>Ficus sp.</i>	0.24	4	6	Suppressed growth, fair condition

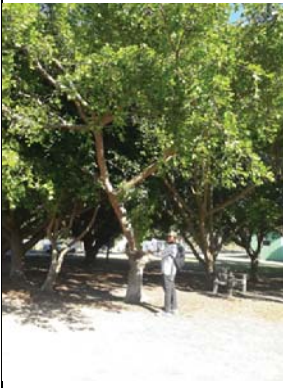
<i>Ficus sp.</i>	0.44	7	8-9	Fair condition
351.

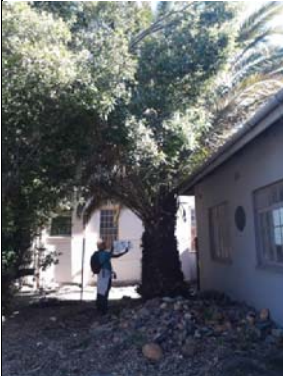
<i>Phoenix canariensis</i>	1.1	8	10	Clear stem(4), good condition, branches on the building
352.

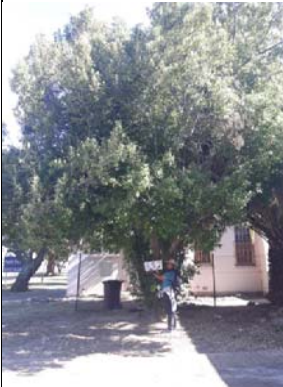
<i>Wild peach</i>	1.1	12	11-12	Spreading, good condition, mature

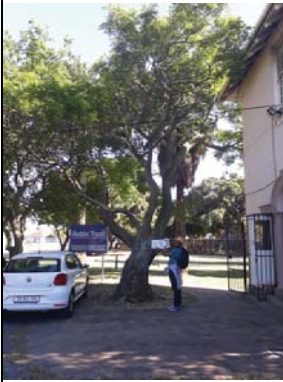
<i>Melia azedarach</i>	1.2	12	12-13	Enlarged base, mature, dead wood, good condition
354.

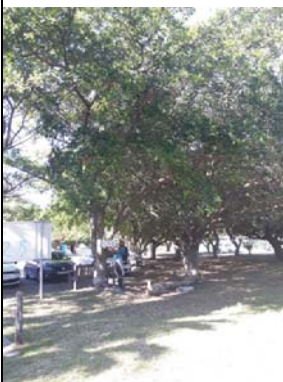
<i>Ficus sp.</i>	0.43	18	10-12	Good condition
355.

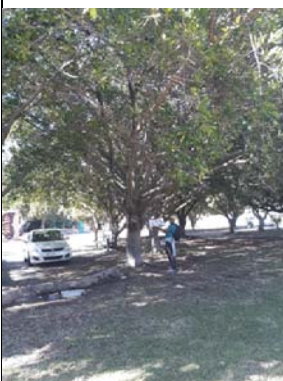
<i>Ficus sp.</i>	0.55	23	10-12	Good condition

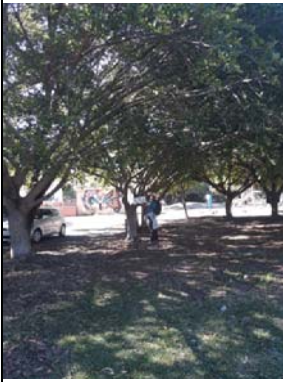
<i>Ficus sp.</i>	0.44	15	9-10	Good condition
357.

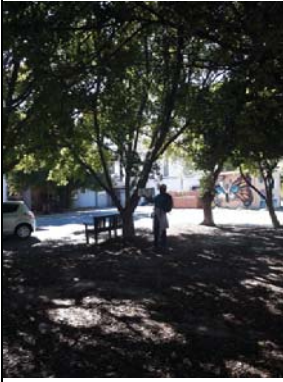
<i>Ficus sp.</i>	0.44	15	9-10	Good condition, slightly suppressed
358.

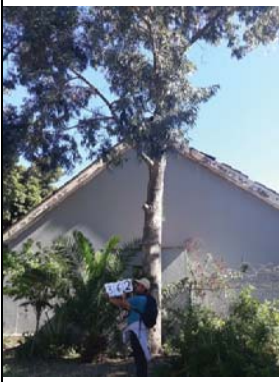
<i>Eucalyptus</i>	0.55	5	14	Good condition
363.

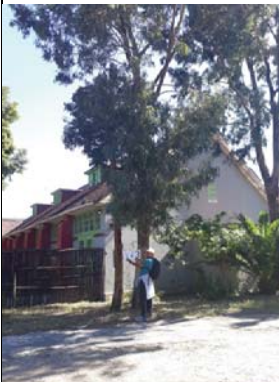
<i>Eucalyptus</i> X2	1	5	14	Fair condition
364.

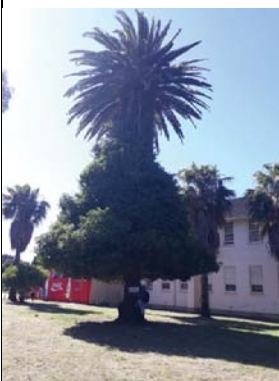
<i>Phoenix canariensis</i>	1.1	10	16	Stem covered with Ivy, good condition

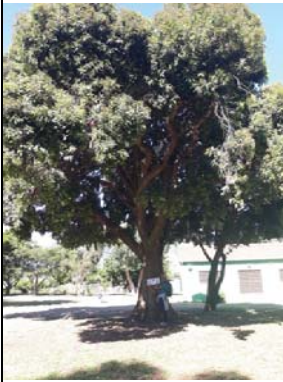
<i>Eucalyptus ficifolia</i>	1.2	21	12-13	Mature, Spreading canopy, good condition
372.

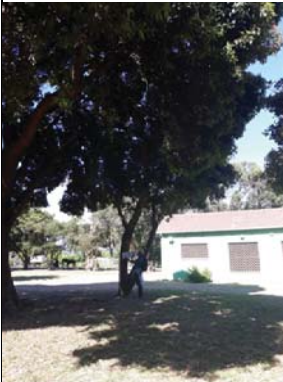
<i>Eucalyptus ficifolia</i>	0.68	6.5	9-10	Split stem(1), suppressed growth, poor condition, dead wood
373.

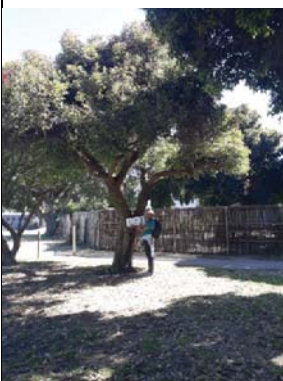
<i>Eucalyptus ficifolia</i>	0.6	6	7-8	Dead wood, mature, fair condition

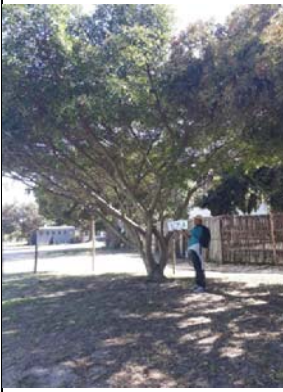
<i>Ficus sp.</i>	MS (0.5)	10	7-8	Good condition
375.

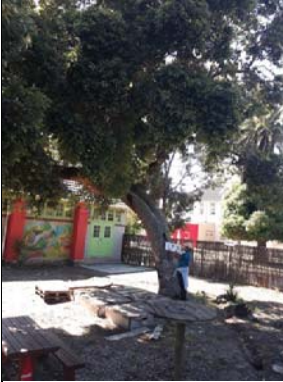
<i>Eucalyptus ficifolia</i>	1.25	19	11-12	Spreading canopy, mature, leaning
376.

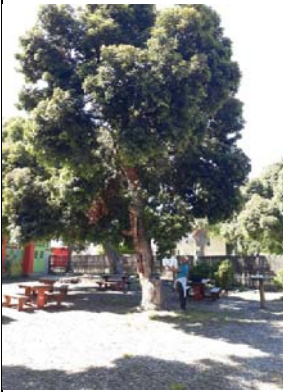
<i>Eucalyptus ficifolia</i>	1	13	11-12	Mature, good condition, disease

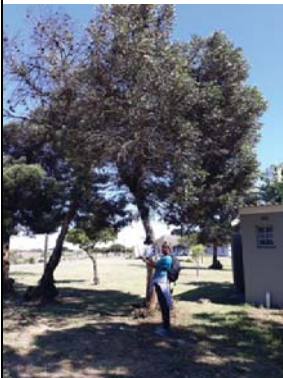
<i>Eucalyptus sp.</i>	0.3	4	6	Enlarged base, poor condition, wind blown
384.

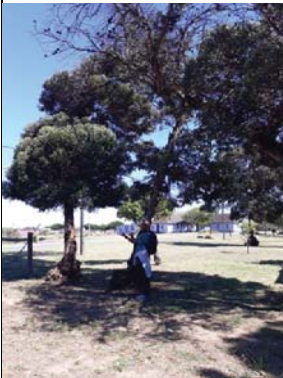
<i>Eucalyptus sp.</i>	0.3	4	6	Enlarged base, poor condition, wind blown
385.

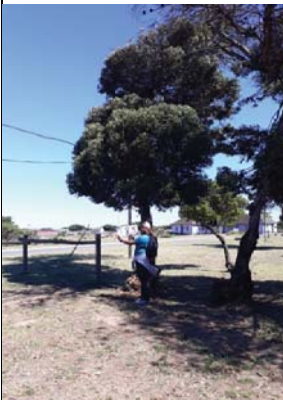
<i>Eucalyptus sp.</i>	0.3	4	6	Enlarged base, poor condition, wind blown

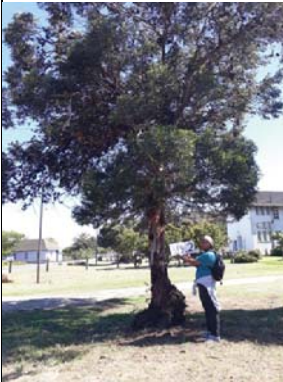
<i>Eucalyptus sp.</i>	0.3	4	6	Poor condition, wind blown
393.

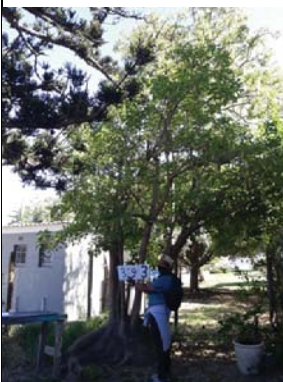
<i>Phytolacca dioica</i>	1.7	4	9	Enlarged base
394.

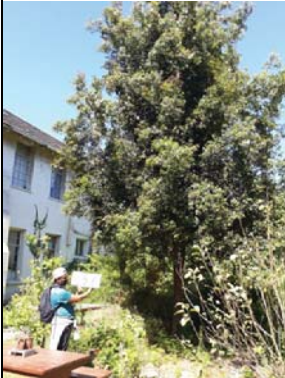
<i>Syzygium paniculatum</i>	0.2	7	10	Good condition
397.

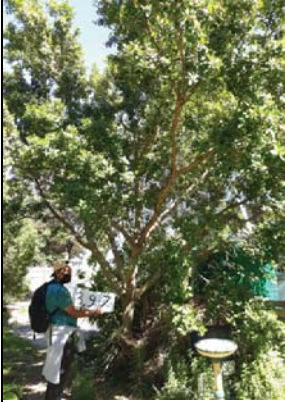
<i>Ficus microcarpa</i>	0.2	9	7-8	Good condition

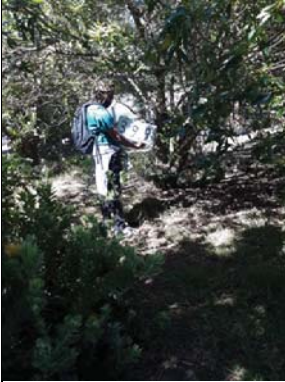
<i>Myoporum sp.</i>	0.4	11	4	Fair condition-poor condition
400.

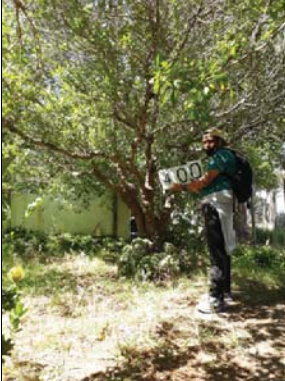
<i>Myoporum sp.</i>	0.4	11	4	Fair condition-poor condition

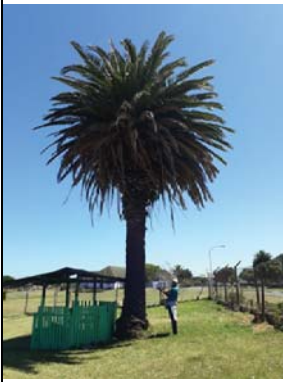
<i>Phoenix canariensis</i>	0.8	7	15	(1-6) clear stem
402.

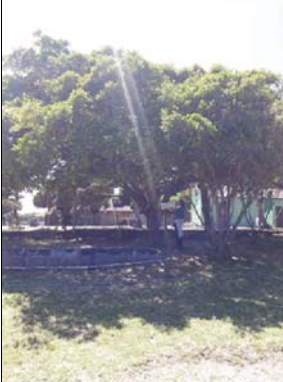
<i>Ficus sp.</i>	0.46	13	7-8	Spreading canopy, good condition, healthy
403.

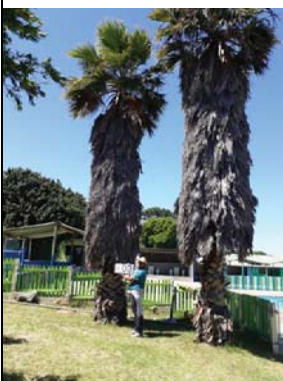
<i>Washingtonia robusta</i>	0.7	3-5	10-12	Good condition, requires pruning

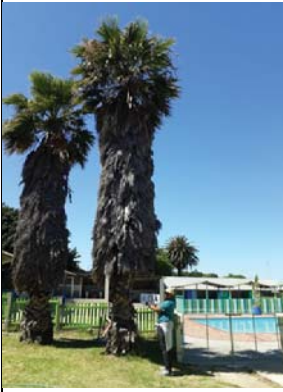
<i>Washingtonia robusta</i>	0.7	3-5	13	Good condition, requires pruning
405.

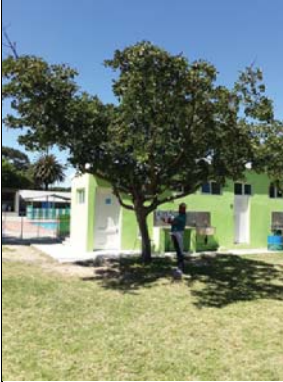
<i>Ficus sp.</i>	0.3	8	5-5	Leaning stem, good condition
406.

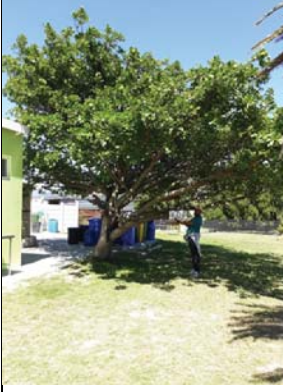
<i>Ficus sp.</i>	0.5	13	6	Leaning stem, good condition

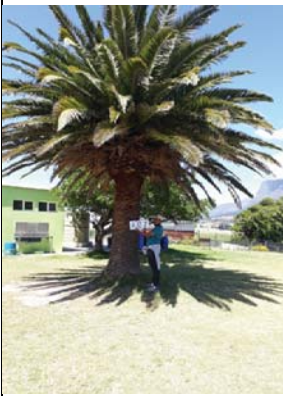
<i>Phoenix canariensis</i>	0.6	9	9-10	(3.5) clear stem, good condition
408.

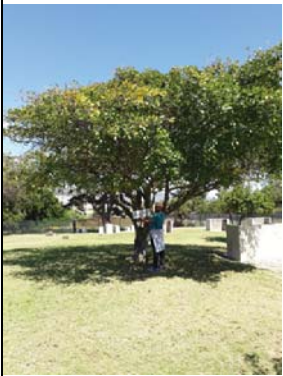
<i>Ficus sp.</i>	0.5	13	6	Good condition
409.

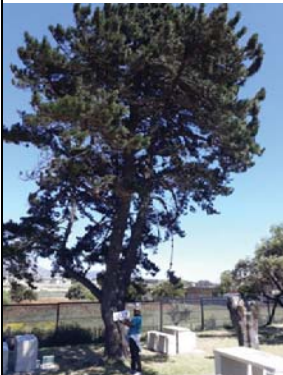
<i>Prunus sp.</i>	0.95	13	14	Poor condition, dead wood, wind blown

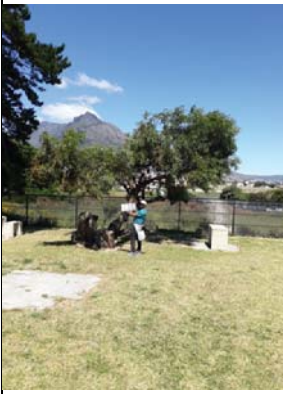
<i>Acacia saligna</i>	2	8	4.5	Clustering, half dead, poor condition
411.

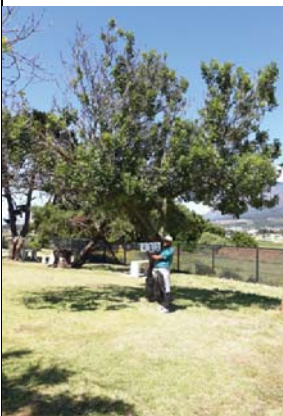
<i>Fraxinus sp.</i>	0.5	8	7-8	Poor-fair condition, dead wood, wind blown
412.

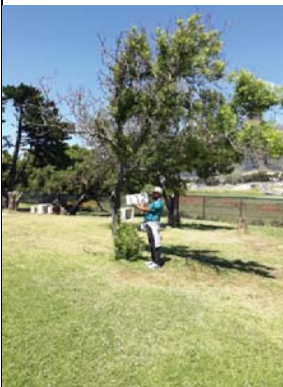
<i>Fraxinus sp.</i>	0.2	5	4	Poor-fair condition

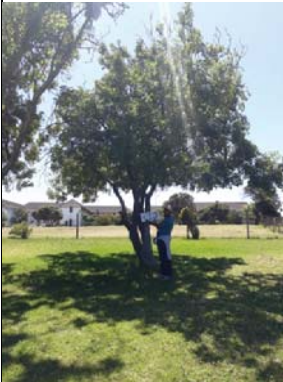
<i>Fraxinus sp.</i>	0.45	8	8-9	Split stem(1),fair condition
414.

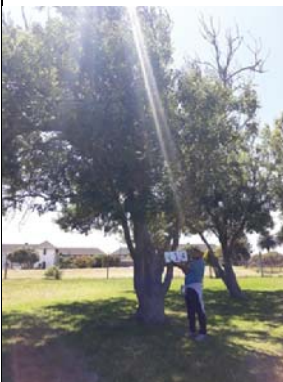
<i>Fraxinus sp.</i>	0.7	11	12	Multi stem (0.5), poor-fair condition, dead wood
415.

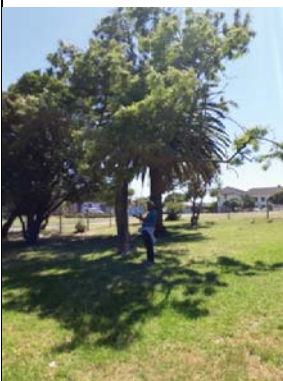
<i>Grevillea sp.</i>	0.5	10	12	Poor condition, dead wood

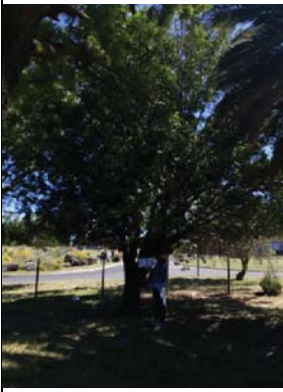
<i>Ilex sp.</i>	0.51	8	9-10	Multi stem(0.5), good condition
417.

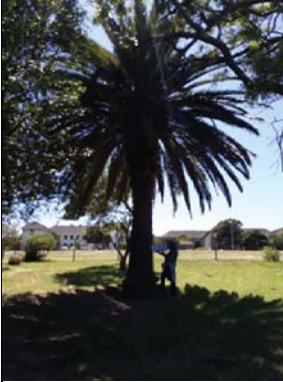
<i>Phoenix canariensis</i>	0.9	8	12	(8-9) clear stem, good condition
418.

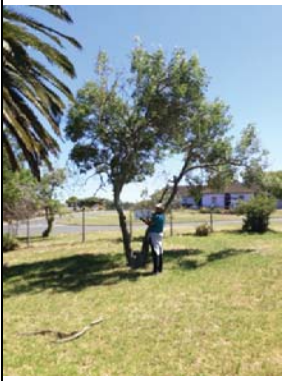
<i>Fraxinus sp.</i>	0.5	7	6-7	Split stem (0.5), poor condition, windblown, dead wood

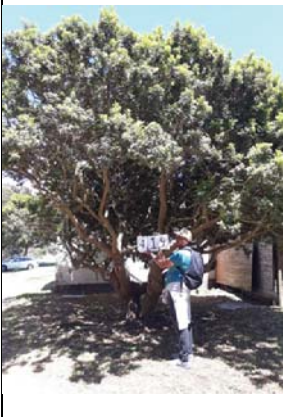
<i>Schinus terebinthifolius</i>	MS (0.1)	10	5-6	Spreading, good condition, invader
420.

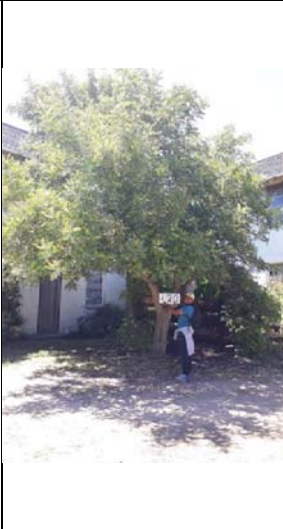
<i>Ceratonia siliqua</i>	0.33	8	8-9	Good condition
421.

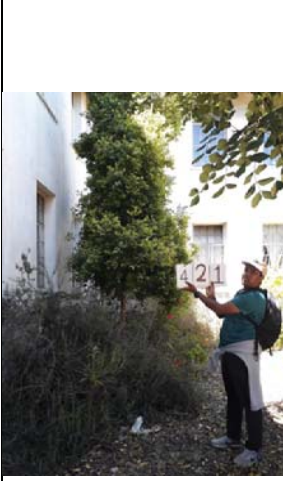
<i>Syzygium paniculatum</i>	0.2	3	5-6	Upright, fair condition

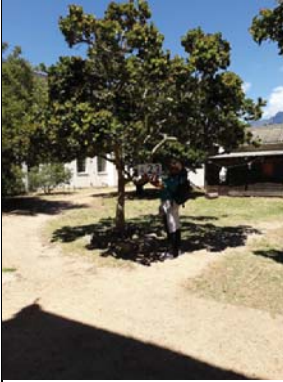
<i>Syzygium cordatum</i>	0.21	5.5	4.5	Good condition
424.	 	<i>Syzygium cordatum</i>	0.21	5.5	6.5	Good condition

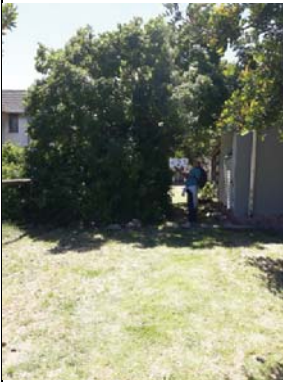
<i>Celtis sp.</i>	0.25	9.5	7-8	Good condition, healthy
426.

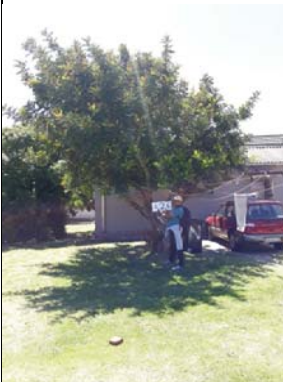
<i>Ceratonia sp.</i>	MS (0.95)	9.5	5-6	Fair condition, twining branches
427.

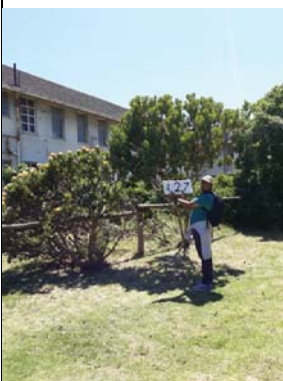
<i>Leucospermum sp.</i>		5.5	2	Mature, windblown, fair-poor condition

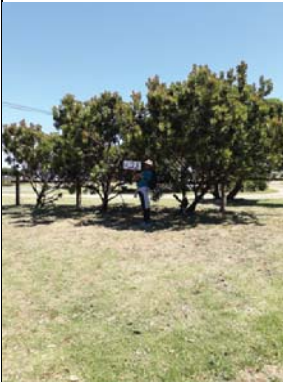
<i>Protea sp. cluster</i>		8	3	Fair condition, mature
429.

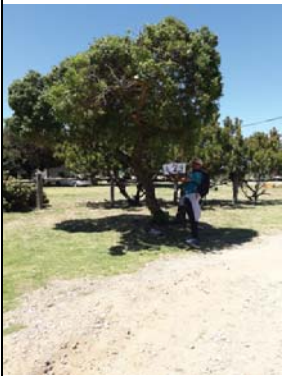
<i>Myoporum sp.</i>	MS (1.2)	4.5	4.5	Poor condition, dead wood
430.

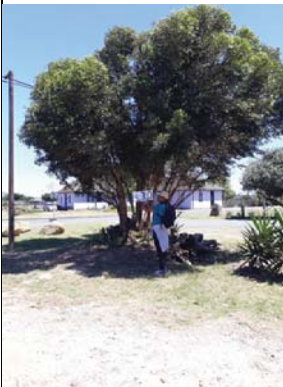
<i>Eucalyptus sp.</i>	2.7	10	6	Cluster, poor condition, re-sprouting

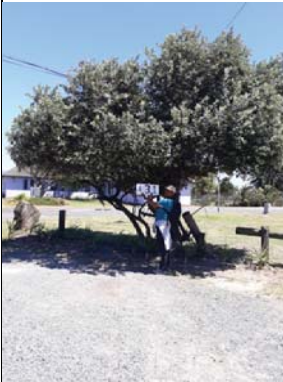
<i>Brachylaena sp.</i>	MS (1.2)	9.5	15	Fair condition, over grown
432.

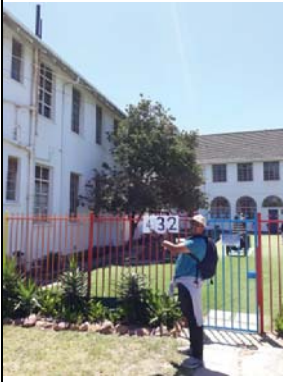
<i>Kiggelaria africana</i>	0.3	5	8-9	Good condition, upright against the building
433.

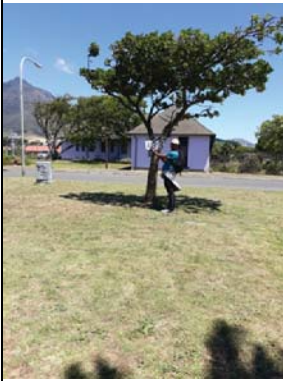
<i>Erythrina sp.</i>	0.27	5	5	Good condition

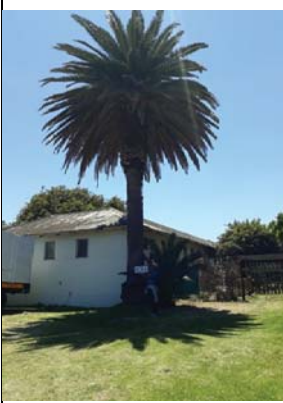
<i>Phoenix canariensis</i>	1.2	8	14	(10 m) clear stem, good condition
435.

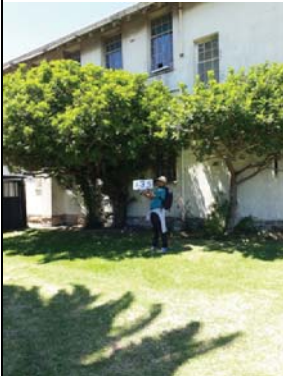
<i>Schinus terebinthifolius</i> x2		12	5-6	Self-seed, growing into the building, fair condition
436.

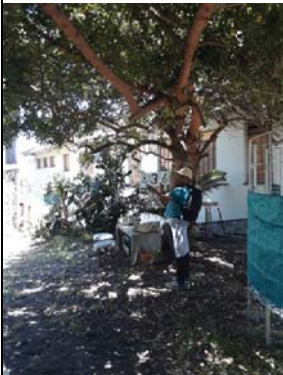
<i>Ceratonia siliqua</i>	0.45	8	6-9	Spreading canopy, good condition

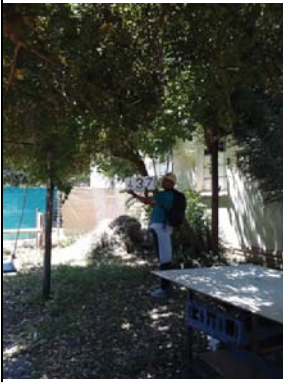
<i>Morus alba</i>	MS (0.5)	5	6-7	Leaning, fair condition, self-seed
438.

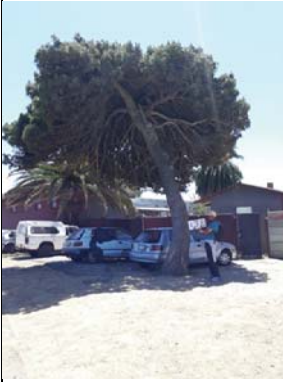
<i>Pinus sp.</i>	0.55	11	9-10	Leaning stem, windblown, old, poor-fair condition
439.

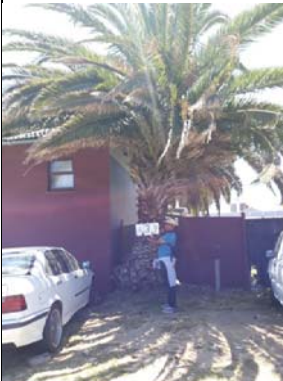
<i>Phoenix canariensis</i>	0.7	8	7-8	(5m) clear stem, fair condition, leaning against the building

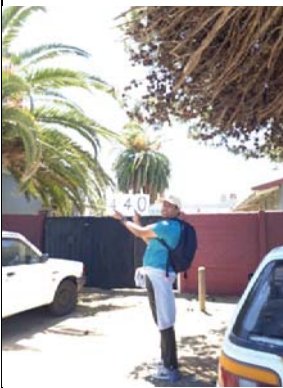
<i>Phoenix canariensis</i>	0.6	5	10	(7-8m) Clear stem
441.

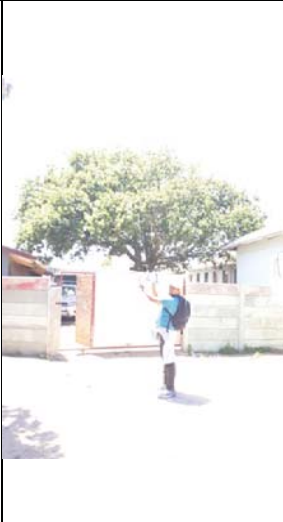
<i>Quercus robur</i>	1.1	14	12-13	Mature, good condition, spreading canopy
442.

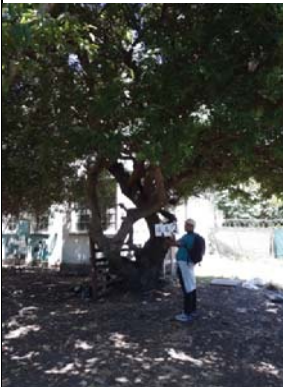
<i>Schinus terebinthifolius</i>	0.7	9	10-12	Multi stem (0.5), twining branches, good condition, invader

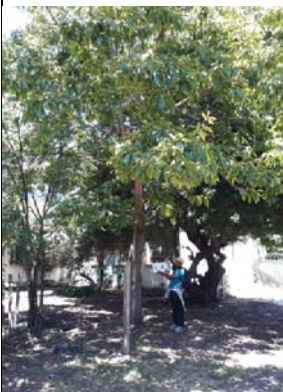
<i>Castanea sativa</i>	0.35	9	9-10	Dead wood, good condition
444.

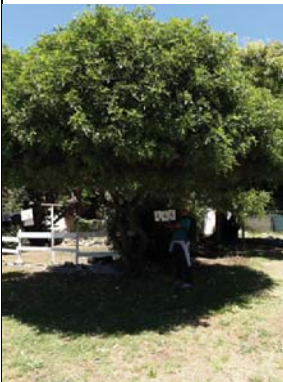
<i>Schinus terebinthifolius</i>	MS (0.6)	9	6-7	Fair condition, invader, twining stem
445.

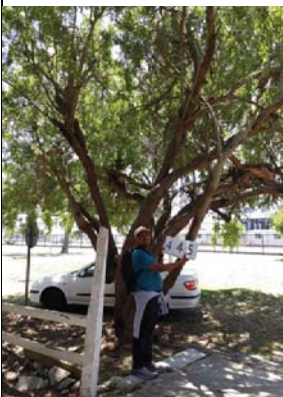
<i>Searsia pendulina</i>	MS (0.7)	12	7-8	Twining branches, good condition

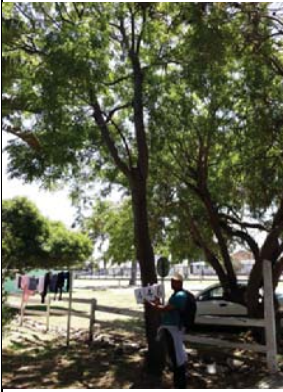
<i>Melia azedarach</i>	0.37	10	10-110	Good condition, invader
447.

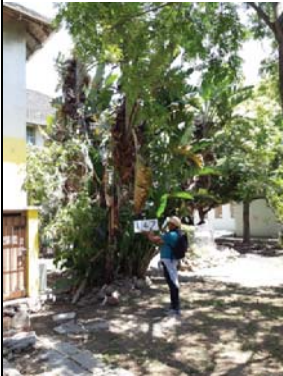
<i>Strelitzia nicolai</i>		5	10	Cluster (3m), good-fair condition
448.

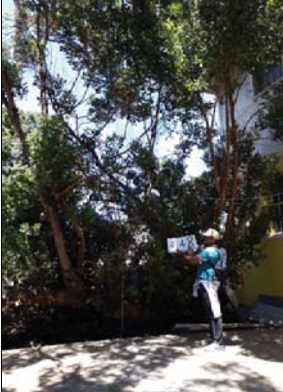
<i>Eucalyptus sp.</i>	9	10	10	Poor condition

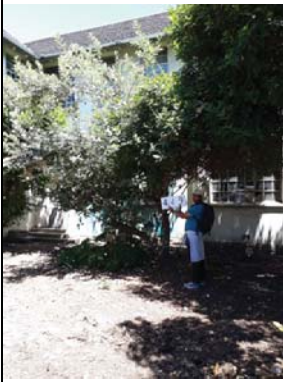
<i>Brachylaena sp.</i>	0.25	7	4.5	Fair condition, growing into another tree (<i>Schinus terebinthifolius</i>)
450.

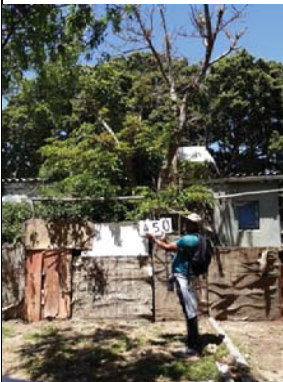
<i>Phytolacca dioica</i>	1	4	9-10	Half dead, poor condition
451.

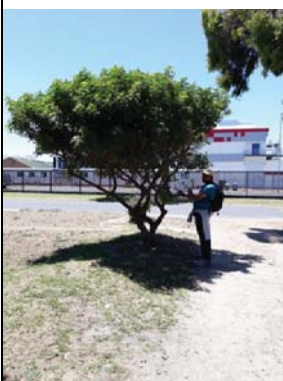
<i>Schinus terebinthifolius</i>	0.25	4.5	4	Twining stem, fair condition

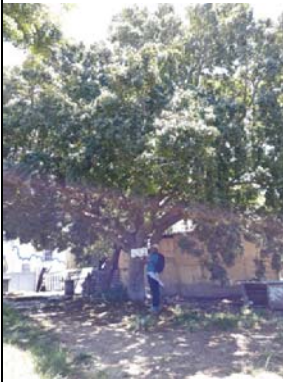
<i>Ficus microcarpa</i>	0.6	14	9-10	Good condition
453.

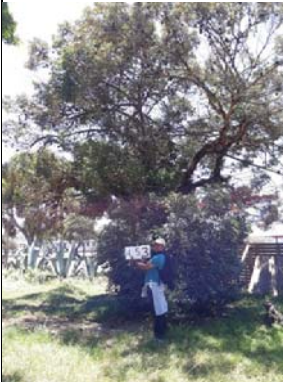
<i>Eucalyptus sp.</i>	1	7-8	9-10	Poor-fair condition
454.

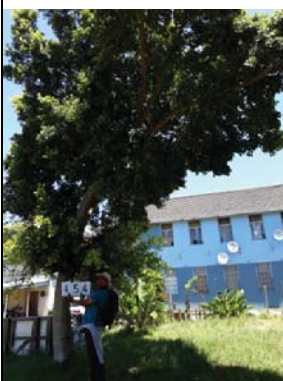
<i>Ficus microcarpa</i>	0.4	9-10	(10-12)	Good condition

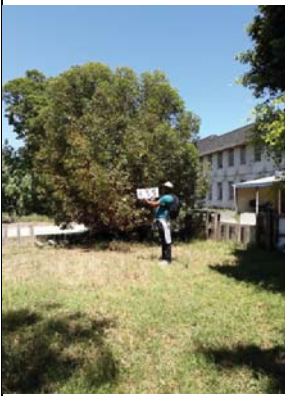
<i>Eucalyptus sp.</i>		5	6	Poor condition
456.

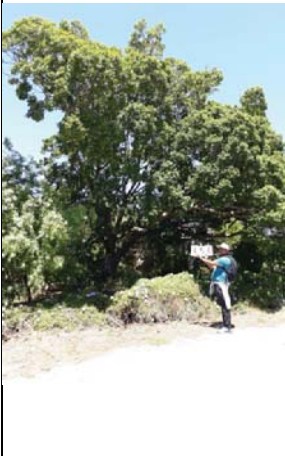
<i>Ficus microcarpa</i>	1	16	10-12	Good condition, spreading
457.

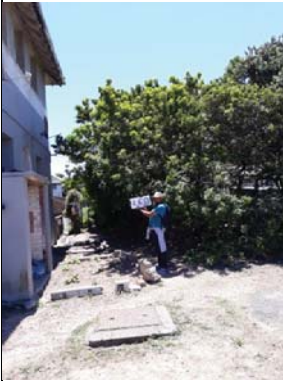
<i>Schinus terebinthifolius</i>	1	13	5.5	Spreading canopy

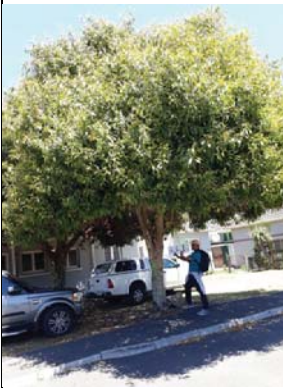
<i>Syzygium guineense</i>	0.37	10	10	Good condition
462.

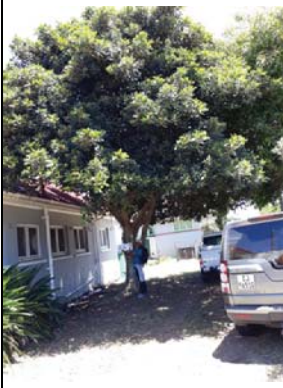
<i>Ficus sp.</i>	0.5	13	11	Good condition
463.

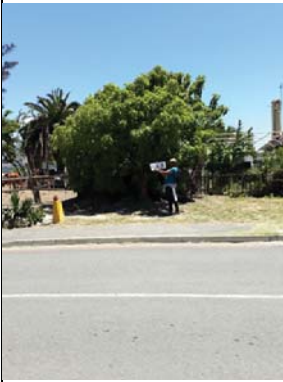
<i>Phytolacca dioica</i>	9	9	3	Re-sprouting stump, enlarged base, fair condition
465.	 	<i>Eriobotrya japonica</i>	0.16	4	4	Good condition,
466.

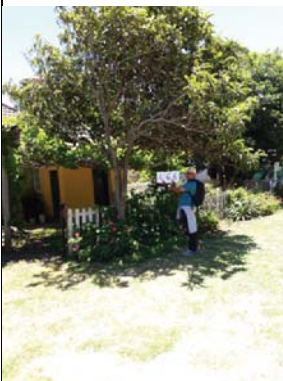
<i>Eriobotrya japonica</i>	0.18	7	6	Fair condition, windblown

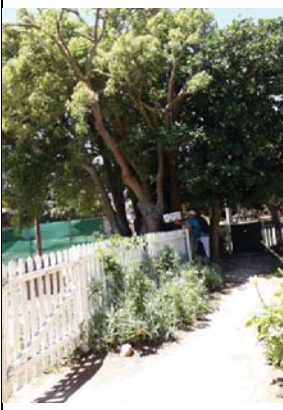
<i>Phytolacca dioica</i>	MS (3)	13	11-12	Enlarged base, fair condition, mature, invader
471.

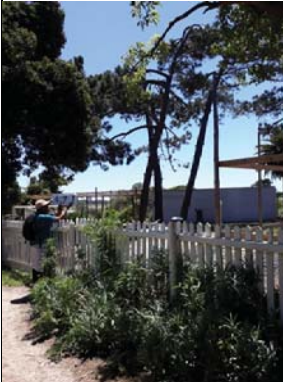
<i>Pinus pinea X4</i>	0.8	16	13	Poor condition, windblown, dead wood
472.

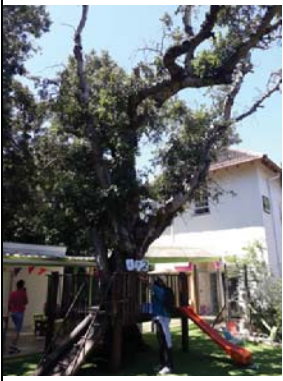
<i>Ceratonia siliqua</i>	0.9	9	12	Dead wood, mature, poor condition
