Cape Town, Oude Molen Precinct

TREES AND SHRUBS QUALITY SURVEY

Planning Partners
Landscape Architects

Western Cape Government

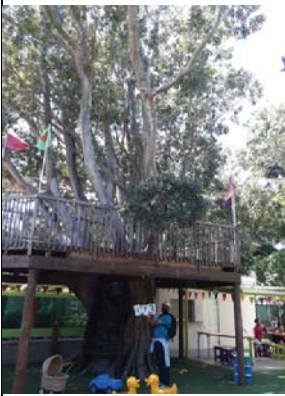
<i>Ficus sp.</i>	2.1	17	19+	Good condition, mature, spreading canopy
474.

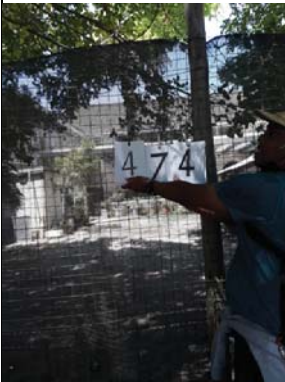
<i>Phoenix canariensis</i>	1	7	17	(14m) clear stem, good condition
475.

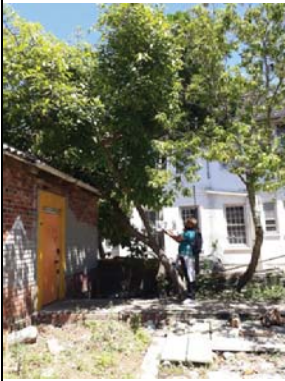
<i>Harpephyllum sp.</i> <i>Persea Americana</i> <i>Prunus persica</i> x2	0.2	13	8-9	Fair condition

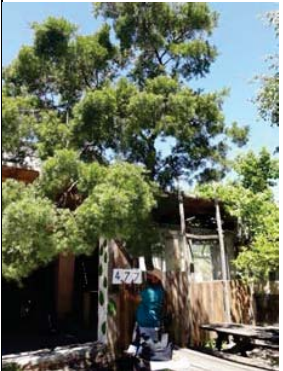
<i>Podocarpus sp.</i>	0.2	6	7-8	Upright, fair condition
478.

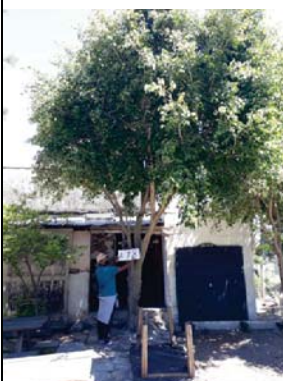
<i>Ficus benjamina</i>	0.27	8	8-9	Pot plant, good condition

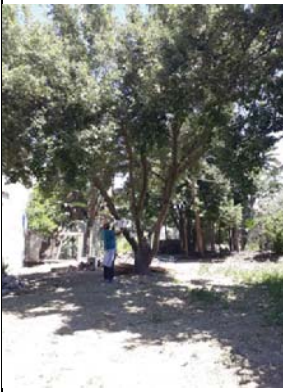
<i>Kiggerlaria africana</i>	0.6	10	9-10	Good condition
480.

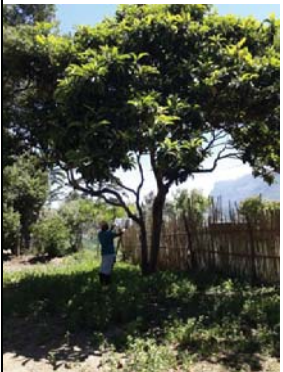
<i>Eriobotrya japonica</i>	0.5	8	8-9	Good condition, invader
481.

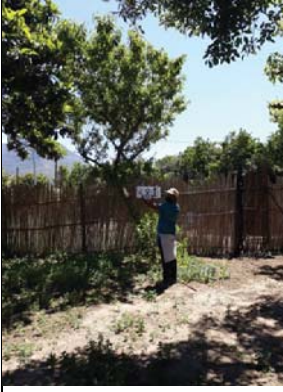
<i>Prunus persica</i>	0.25	4	6	Fair condition, fruiting

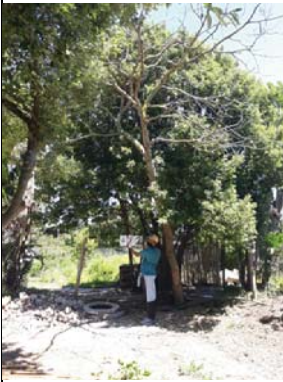
<i>Kiggelaria africana</i>	MS (0.5)	6	8-9	Fair condition
483.

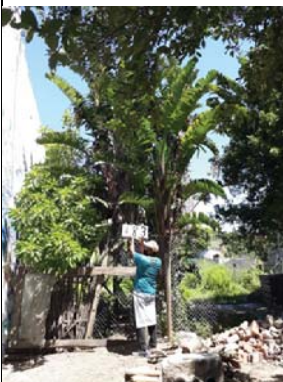
<i>Strelitzia nicolai</i>	1	4	8-9	Cluster, good condition
484.

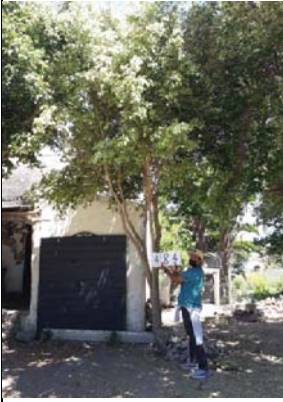
<i>Ficus benjamina</i>	0.3	5	5-6	Fair condition, suppressed growth

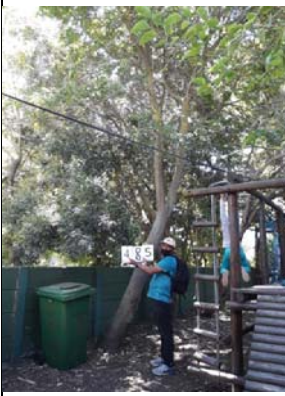
<i>Harpephyllum sp.</i>	0.24	9	10-11	Leaning, good condition
486.	 	<i>Olea sp.</i>	0.57	4	8-9	Good-fair condition
487.	 	<i>Acacia galpinii</i>	0.4	9	10-11	Leaning, fair condition

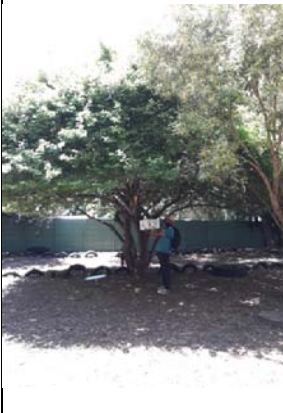
<i>Prunus sp.</i>	MS (0.5)	11	5	Good condition
489.

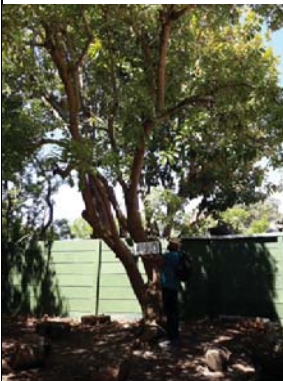
<i>Olea sp.</i>	MS (0.5)	6	4-5	
490.

<i>Phytolacca dioica</i>	0.8	8	9	Enlarged base

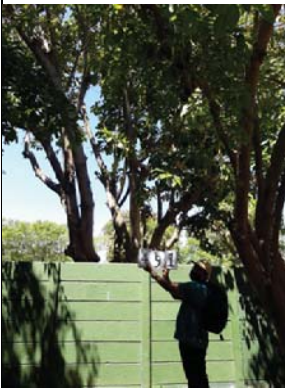
No	TREE PHOTOGRAPHIC RECORD	SPECIES	GRITH (m)	CANOPY (m)	HEIGHT (m)	COMMENT
491.

<i>Ficus elastica</i>				
492.

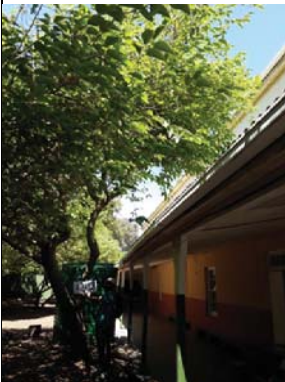
<i>Morus alba</i>	0.4	12	6-7	Leaning, good-fair condition
493.

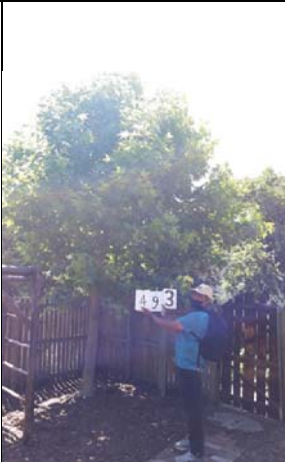
<i>Eriobotrya japonica</i>	0.17	4.5	7	Very healthy

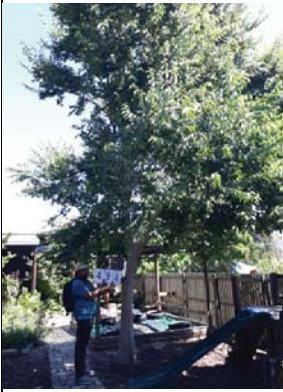
No	TREE PHOTOGRAPHIC RECORD	SPECIES	GRITH (m)	CANOPY (m)	HEIGHT (m)	COMMENT
494.

<i>Celtis sp.</i>	0.2	4-5	7	Good condition
495.

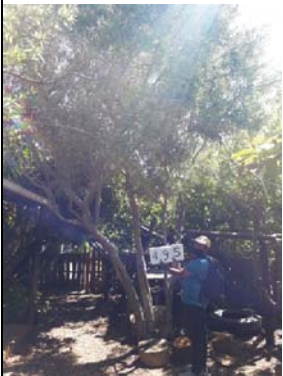
<i>Olea sp.</i>	MS (1)	5	6	Fair condition
496.

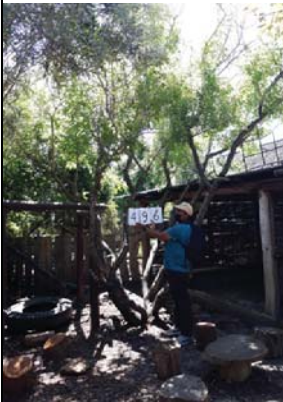
<i>Prunus sp.</i>	MS (0.8)	5	6	Fair condition

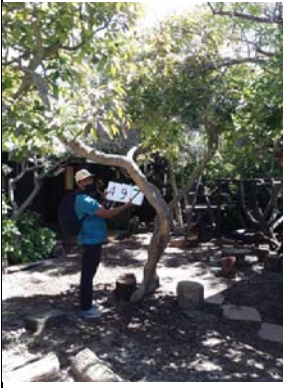
No	TREE PHOTOGRAPHIC RECORD	SPECIES	GRITH (m)	CANOPY (m)	HEIGHT (m)	COMMENT
497.

<i>Persea americana</i>	MS (1)	5	5.5	Fair condition
498.

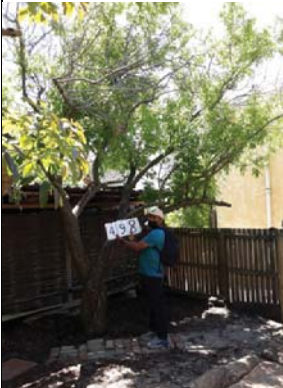
<i>Prunus sp.</i>	0.4	5	5.5	Fair condition
499.

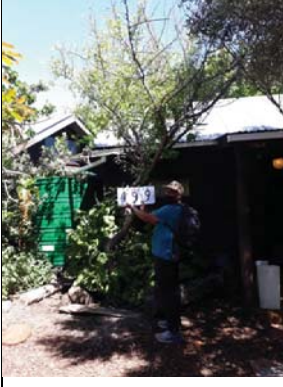
<i>Prunus sp.</i>	0.2	3	4.5	Fair condition

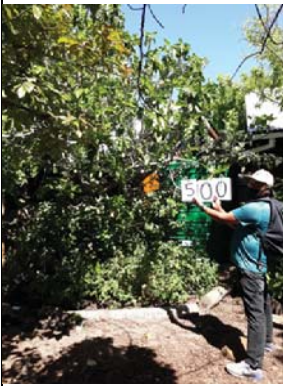
No	TREE PHOTOGRAPHIC RECORD	SPECIES	GRITH (m)	CANOPY (m)	HEIGHT (m)	COMMENT
500.

<i>Ficus carica</i>	0.2	5	5	Fair condition
501.

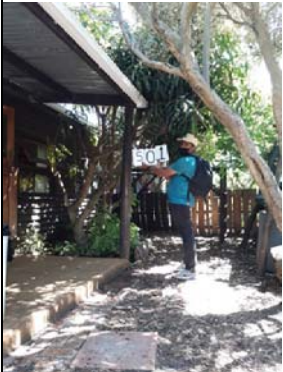
<i>Mangifera indica</i>	0.3	4	4-5	
502.

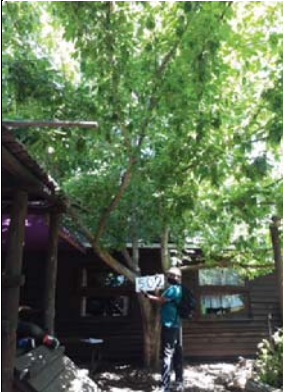
<i>Acer sp.</i>	0.38	9	6-7	Good condition

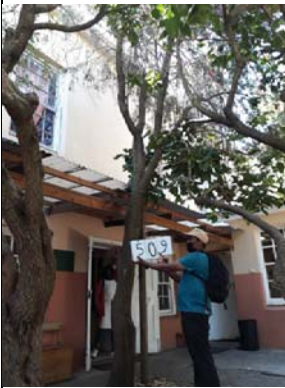
No	TREE PHOTOGRAPHIC RECORD	SPECIES	GRITH (m)	CANOPY (m)	HEIGHT (m)	COMMENT
509.

<i>Callistemon sp.</i>	0.26	5	9-10	Good condition
510.

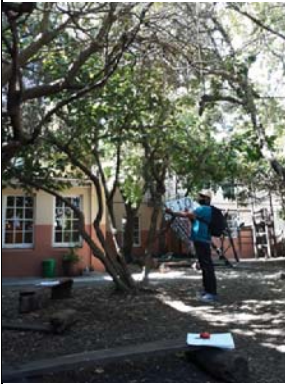
<i>Hibiscus sp.</i>	0.6	7	8	Fair-poor condition
511.

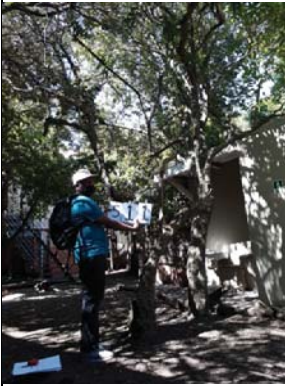
<i>Citharexylum spinosum</i>	0.35	6	8	Suppressed growth, fair condition

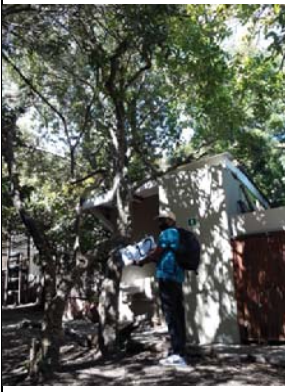
No	TREE PHOTOGRAPHIC RECORD	SPECIES	GRITH (m)	CANOPY (m)	HEIGHT (m)	COMMENT
512.

<i>Kiggelaria africana</i>	0.3	8	8-9	Good condition
513.

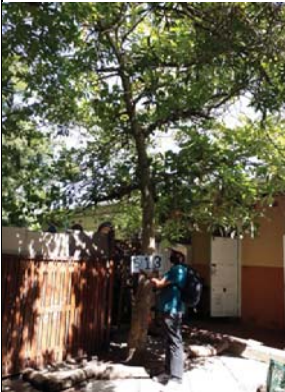
<i>Persea americana</i>	0.25	7	8-9	Fair condition
514.

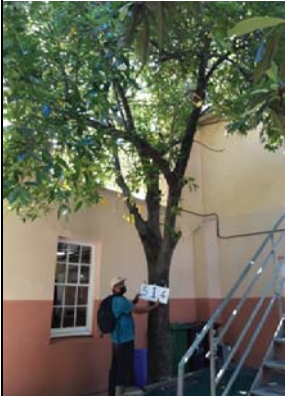
<i>Unknown sp.</i>	0.4	8	10-12	Good condition

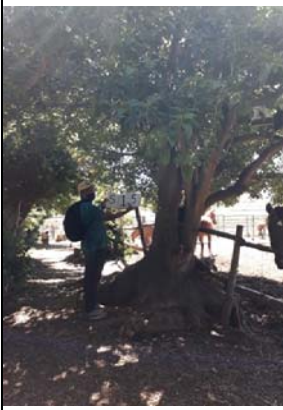
No	TREE PHOTOGRAPHIC RECORD	SPECIES	GRITH (m)	CANOPY (m)	HEIGHT (m)	COMMENT
515.

<i>Phytolacca dioica</i>	2.5	6	7	Enlarged base, fair condition, invader
516.

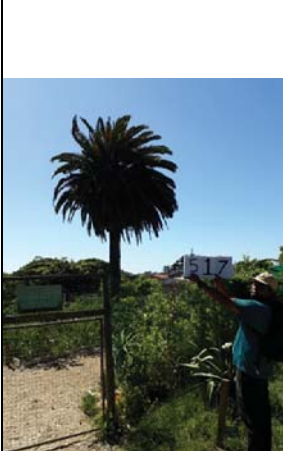
<i>Phoenix canariensis</i>	1	6	12	Good condition, clear stem
